TIMBER
ASSESSMENT
RE-SURVEY

THE WELL HOUSE TAVERN
ROYAL CLARENCE HOTEL
CATHEDRAL YARD
EXETER

January 2022

DEMAUS BUILDING DIAGNOSTICS Ltd
STAGBATCH FARM, LEOMINSTER, HEREFORDSHIRE HR6 9DA
Tel. 01568 615662

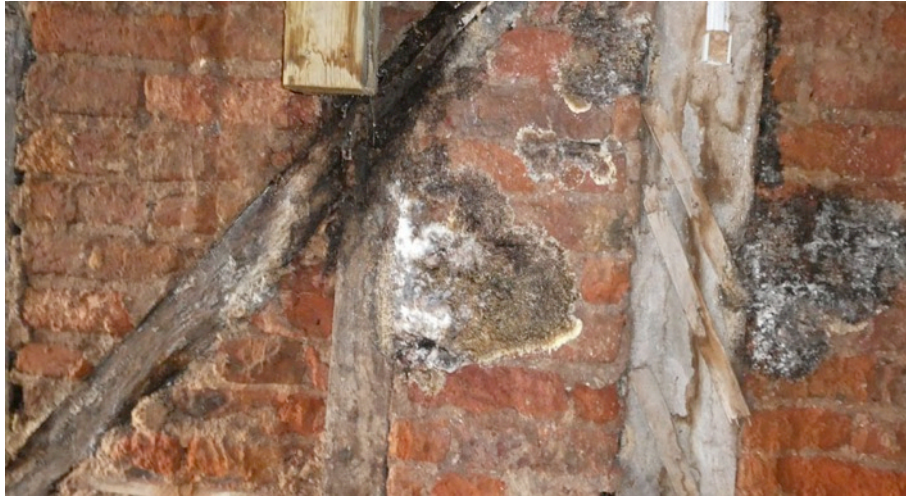
5.2 Rainwater is penetrating the party wall between No.16 and the adjacent property to the west, resulting in an active fungal outbreak in timbers in the party wall and adjacent flooring below. This is presumably caused by a blockage and/or failure in the rainwater discharge from the new roof.

5.3 The fungus is a brown rot, probably *Coniophora puteana*, commonly known as Cellar rot. However, there are a number of brown rots that exhibit similar characteristics, and specific identification is not essential. All fungi will die when the moisture level in the timber drops below 23-24%mc.

Figure 2. Fungal outbreak on west wall of No.16

- 5.4 On the day of site survey, typical timber moisture content at and near the surface of exposed timbers was 17 -19%mc. Immediately under the roof/gutter leak, timber moisture content was typically greater than 27%mc
- 5.5 No other active or recent degradation caused by fungal or insect activity could be identified in the retained historic timbers.
- 5.6 By visual inspection, there has been no significant additional deformation or dislocation of surviving elements since the 2017 survey.

- 6.2 The rainwater penetration into the party wall between No.16 and the adjacent property at Location A should be remedied as soon as possible.
- 6.3 While the area remains saturated, any chemical treatment will be ineffective. As soon as the water penetration is stopped, the wall will dry and the fungus will die, and any chemical treatment will be unnecessary.

- 6.4 When the structure has dried out, the timbers within the party wall will need to be microdrilled to assess residual strength. It should not be assumed that timbers need to be replaced, just because there has been some fungal activity.

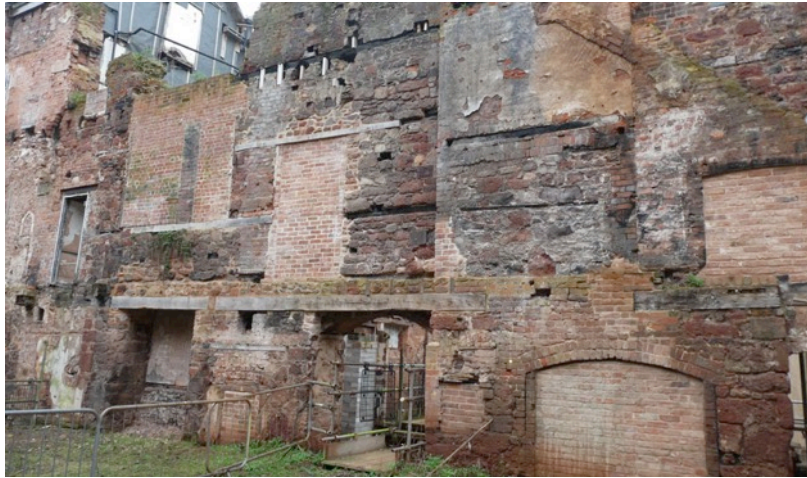
Figure 3. Timber lintels and struts built into saturated exposed masonry walls

The surviving walls are fully exposed to the elements and have not been capped or protected in any way. Timber lintels and vertical props are built into what is effectively saturated brickwork, and will almost inevitably suffer structurally significant fungal degradation at some stage. The lintels are likely to degrade from the ends and from the back, leaving the visible face relatively undamaged until the timber is severely weakened.

The vertical props appear to be softwood, and will readily absorb moisture through the end grain in direct contact with the saturated masonry. Pre-treated timber may have been specified, but it is highly unlikely that the end-grain cut on site would subsequently have been adequately site-treated. Fully pre-treated timber can be vulnerable to fungal attack within five years on site when in contact with saturated masonry.

- 6.8 The surviving walls at Location C are effectively free-standing, with no floors or roof structures to provide bracing. Significant decay in any of the timbers built into the walls could create instability. The exposed walls should be capped as soon as possible, and detailing improved to reduce the risk of degradation. A more durable permanent solution will be required.
- 6.9 Whilst the building fabric remains effectively saturated, chemical treatments will not be effective. Water-based chemicals will quickly dilute to ineffective concentration, and spirit-based chemicals will not penetrate the saturated fabric.
- 6.10 As and when the building fabric becomes protected from the elements and begins to dry, there may be a case for targeted chemical treatment to provide some protection whilst the fabric continues to dry down to

the point where the fungus dies naturally. This typically happens when the timber moisture content drops below 23-24%mc. Chemical treatments do not provide permanent protection against fungal attack

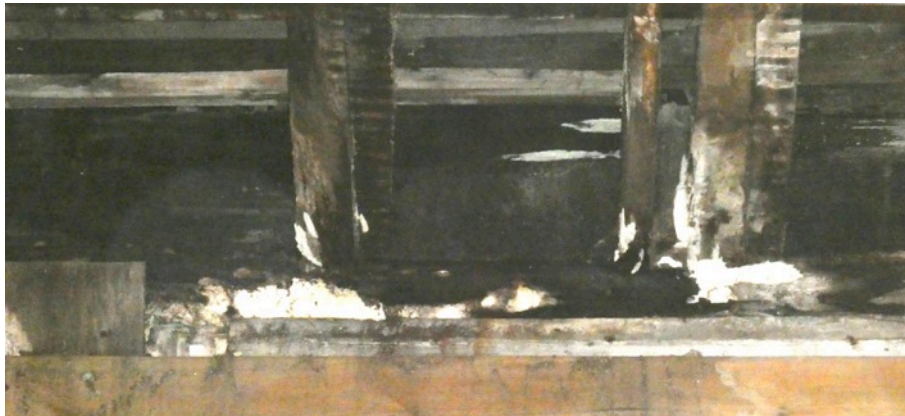
Location D

Figure 4. Fungal degradation in first floor timbers

- 5.13 There is widespread brown rot attack in the first floor joists and floor boards. The timbers could not be safely accessed for close inspection, but by visual inspection from ground level, the fungus is probably Cellar rot (*Coniophora puteana*). Specific identification is not necessary. The fungus is well established, and likely to have resulted in 30-50% l.e.s. in the joists and >50% l.e.s. in the boards.

- 6.11 The remaining timbers at locations D – H could not be safely accessed for detailed testing. By careful visual inspection from ground level, the majority of the timbers have suffered some structurally significant fungal degradation.

- 6.13 Detailed close inspection and testing may allow perhaps 50% of the timbers to be retained with extensive repair and strengthening, but the merit of doing so is questionable.

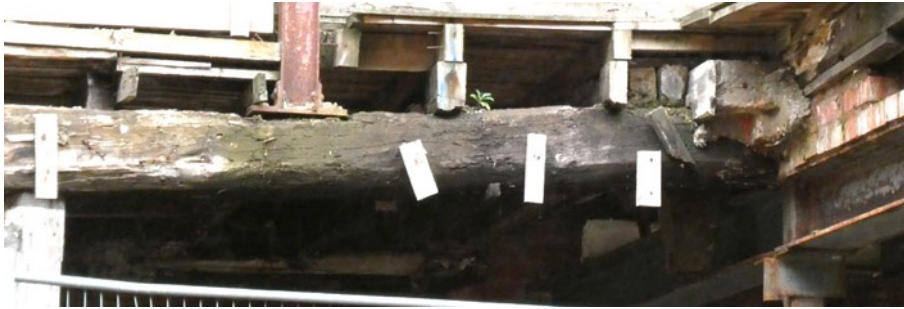
Figure 5. Severe degradation at Location E

- 5.14 The softwood beam is severely degraded at the south (right hand as viewed) end, and to approximately 2m from the end.

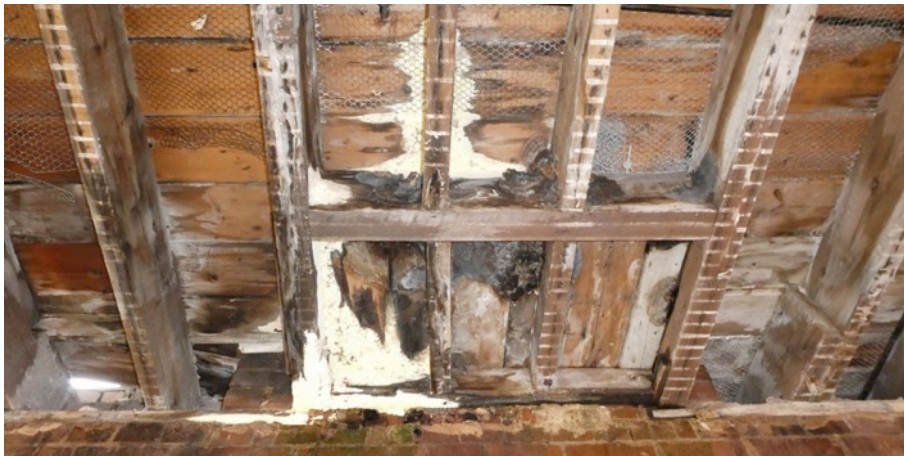
Figure 6. Widespread fungal degradation at Location F

- 5.15 There is widespread and active fungal degradation in the boards and joists.

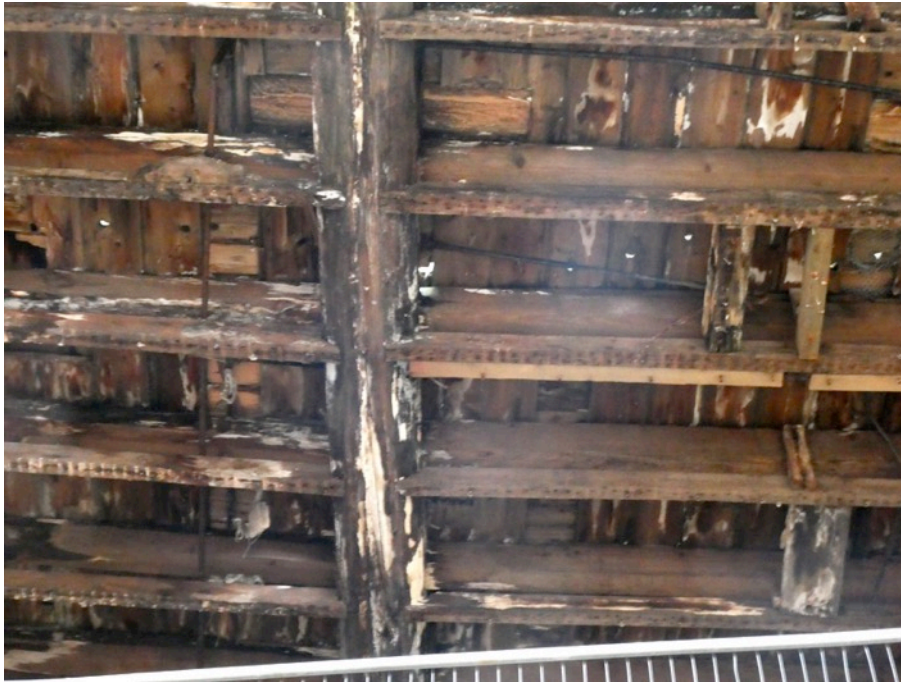
Location G

- 5.16 There is widespread and active fungal degradation in the primary beams, common joists and floorboards. Degradation is likely to be structurally significant.

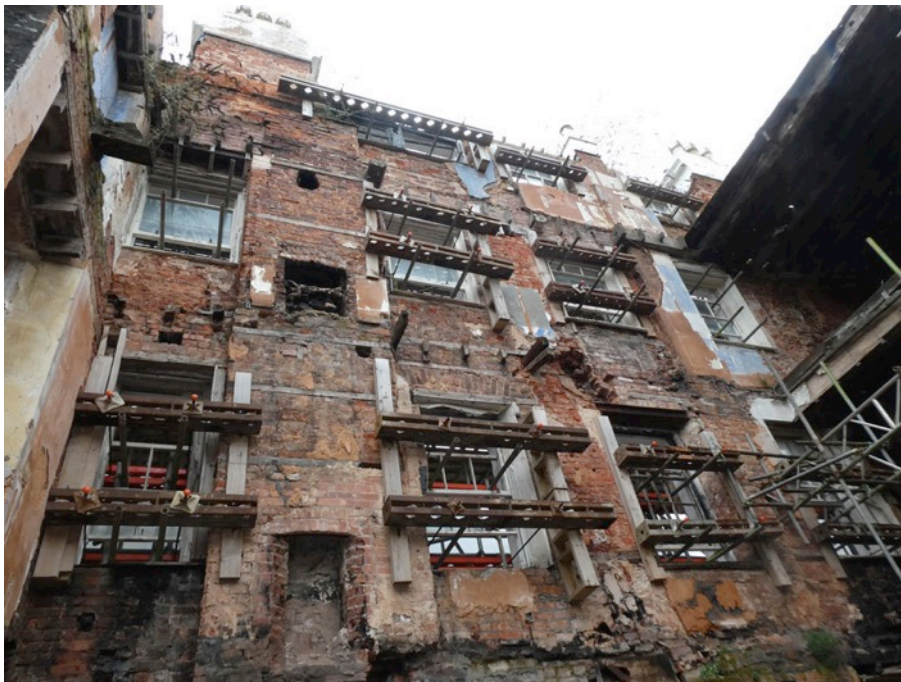
Location H

- 5.17 There are numerous lintels, bonding timbers and other timber elements throughout the wall, all of which are vulnerable to fungal degradation,

which will occur away from the visible face. Any compression in these elements, particularly in a wall with so many other structural discontinuities, and possibly also thermal stress damage following the fire, would create significant instability.

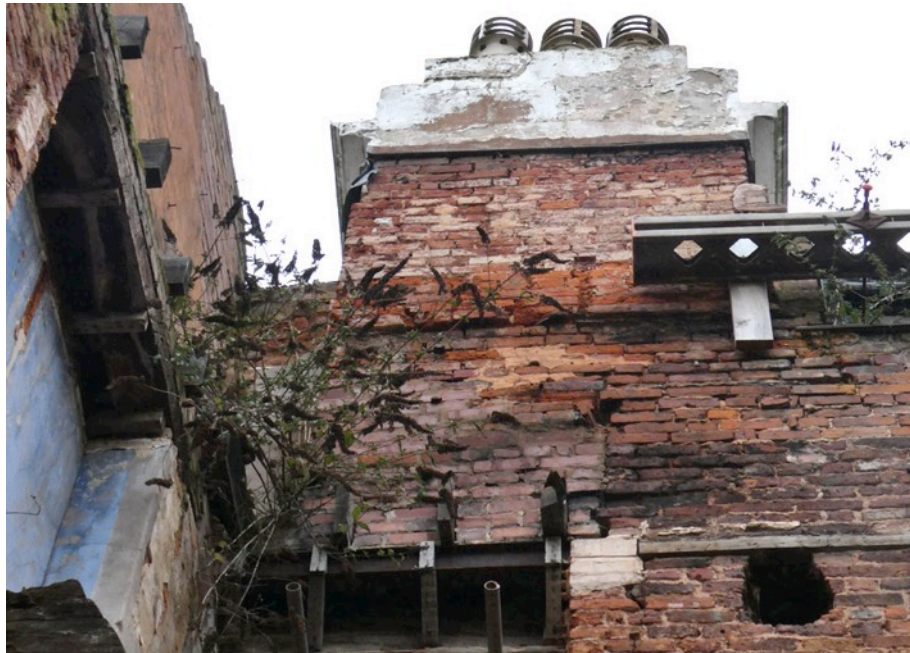
- 5.18 There are well established Buddleia bushes growing at high levels in the masonry. As they grow, the expansion of the roots into bedding courses in the masonry will often jack up substantial sections of masonry, including chimney stacks.

Figure 7. Well established Buddleia bushes growing in the masonry.

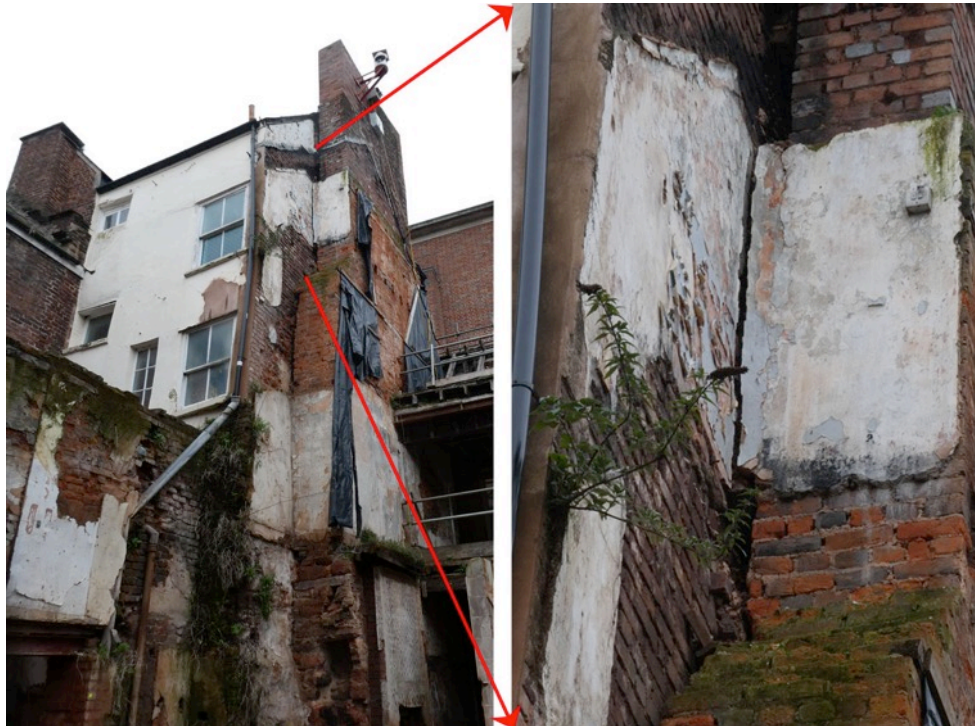
Location I

Figure 8. Potentially unstable chimney stack at the north end of site

- 5.22 Although there is no visible timber present at this location, the chimney stack which, prior to the fire, was braced by the roofs and floors of the Royal Clarence Hotel, appears to have moved out from the party wall. Some or all of this movement may have occurred prior to the fire, but thermal stresses caused by the heating and cooling of the fire is likely to have created further weakness. This increases the potential instability now that it is effectively free-standing. There may be no physical connection between this stack and the adjacent property, and there is likely to be a gap between the adjacent roof pitch and the stack through which water will penetrate. Any bonding timbers and/or bressumers built into the stack/wall will be vulnerable to degradation, and the prolonged saturation of the masonry will tend to reduce its structural coherence.

- 6.14 Although not specifically a timber issue, the stability of elements of the east wall and particularly the chimney stack at the north end is of very great concern.
