**British Standard 5837:2012
Arboricultural Survey**

*Former Aldens Farm Land
Alphington
Exeter
Devon*

7th August 2017

Ref no: TH/X1626/0817

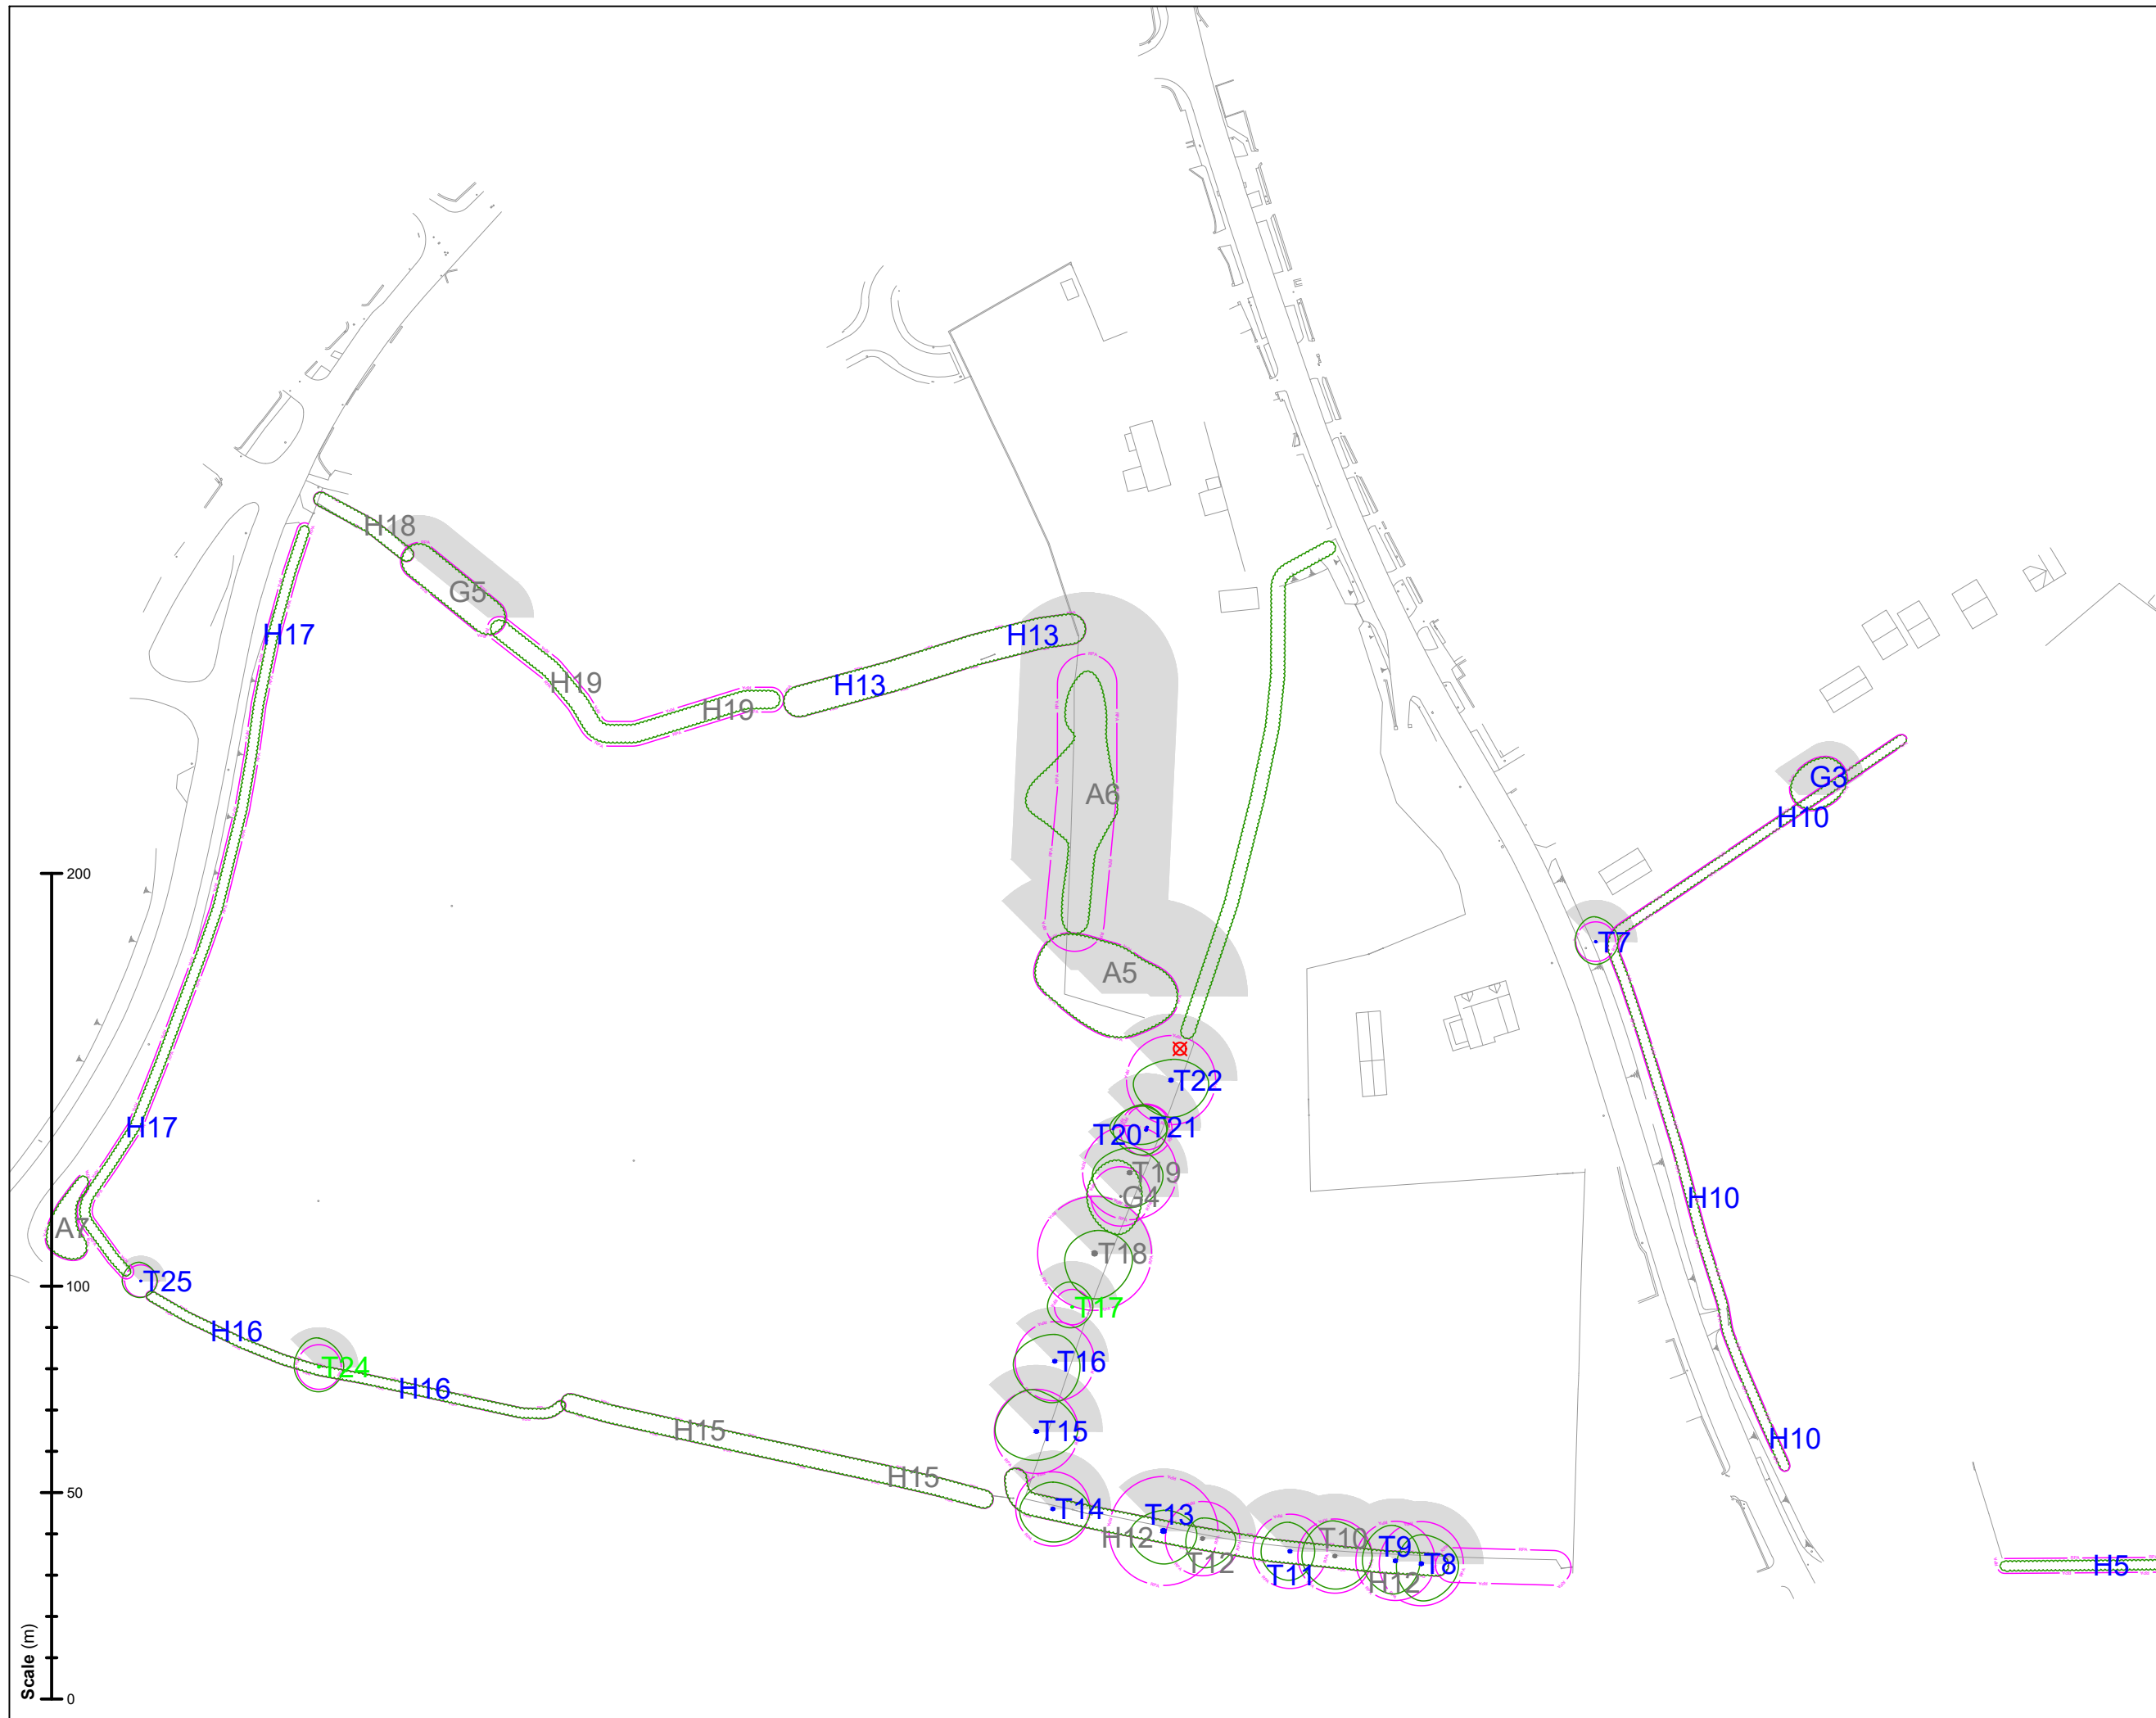
Drawing Title:
Tree Constraints Plan (West)

3.1 Root Protection Areas
<ul style="list-style-type: none">• Root protection areas have been shown on the Tree Constraints Plan in Appendix B.• Where trees are located in hedgerows immediately adjacent to ploughed fields (for example T1 through T4), root distribution is likely to be atypical due to repeated ground disturbance. Rooting in these cases may either be deeper or concentrated along the line of the hedgerow itself where there has been little or no ground disturbance.• The trees adjacent to Markham Lane (T8 through T14) may also have an asymmetric rooting system due to the heavily compacted surface of this public footpath which is also used by agricultural traffic.

3.5 Shading, Dominance and Nuisance
<ul style="list-style-type: none">• Shading and perceived dominance are a potential issue on some of the field boundaries, particularly where there are larger trees, however, the shade paths shown on the Tree Constraints Plans clearly identify these and give guidance as to where occupied structures can be constructed.

- Shading, dominance and nuisance are not considered to be an issue for the hedgerows as these have been flailed to a set height.
- It is noted that the tongue of land to the west of hedgerow H11 is outside of the ownership of the proposed development land and does feature some large Poplars (areas A5 and A6). Whilst none of these trees are individually or collectively outstanding, their removal cannot be assumed and their shade paths have been marked on the Tree Constraints Plan accordingly.

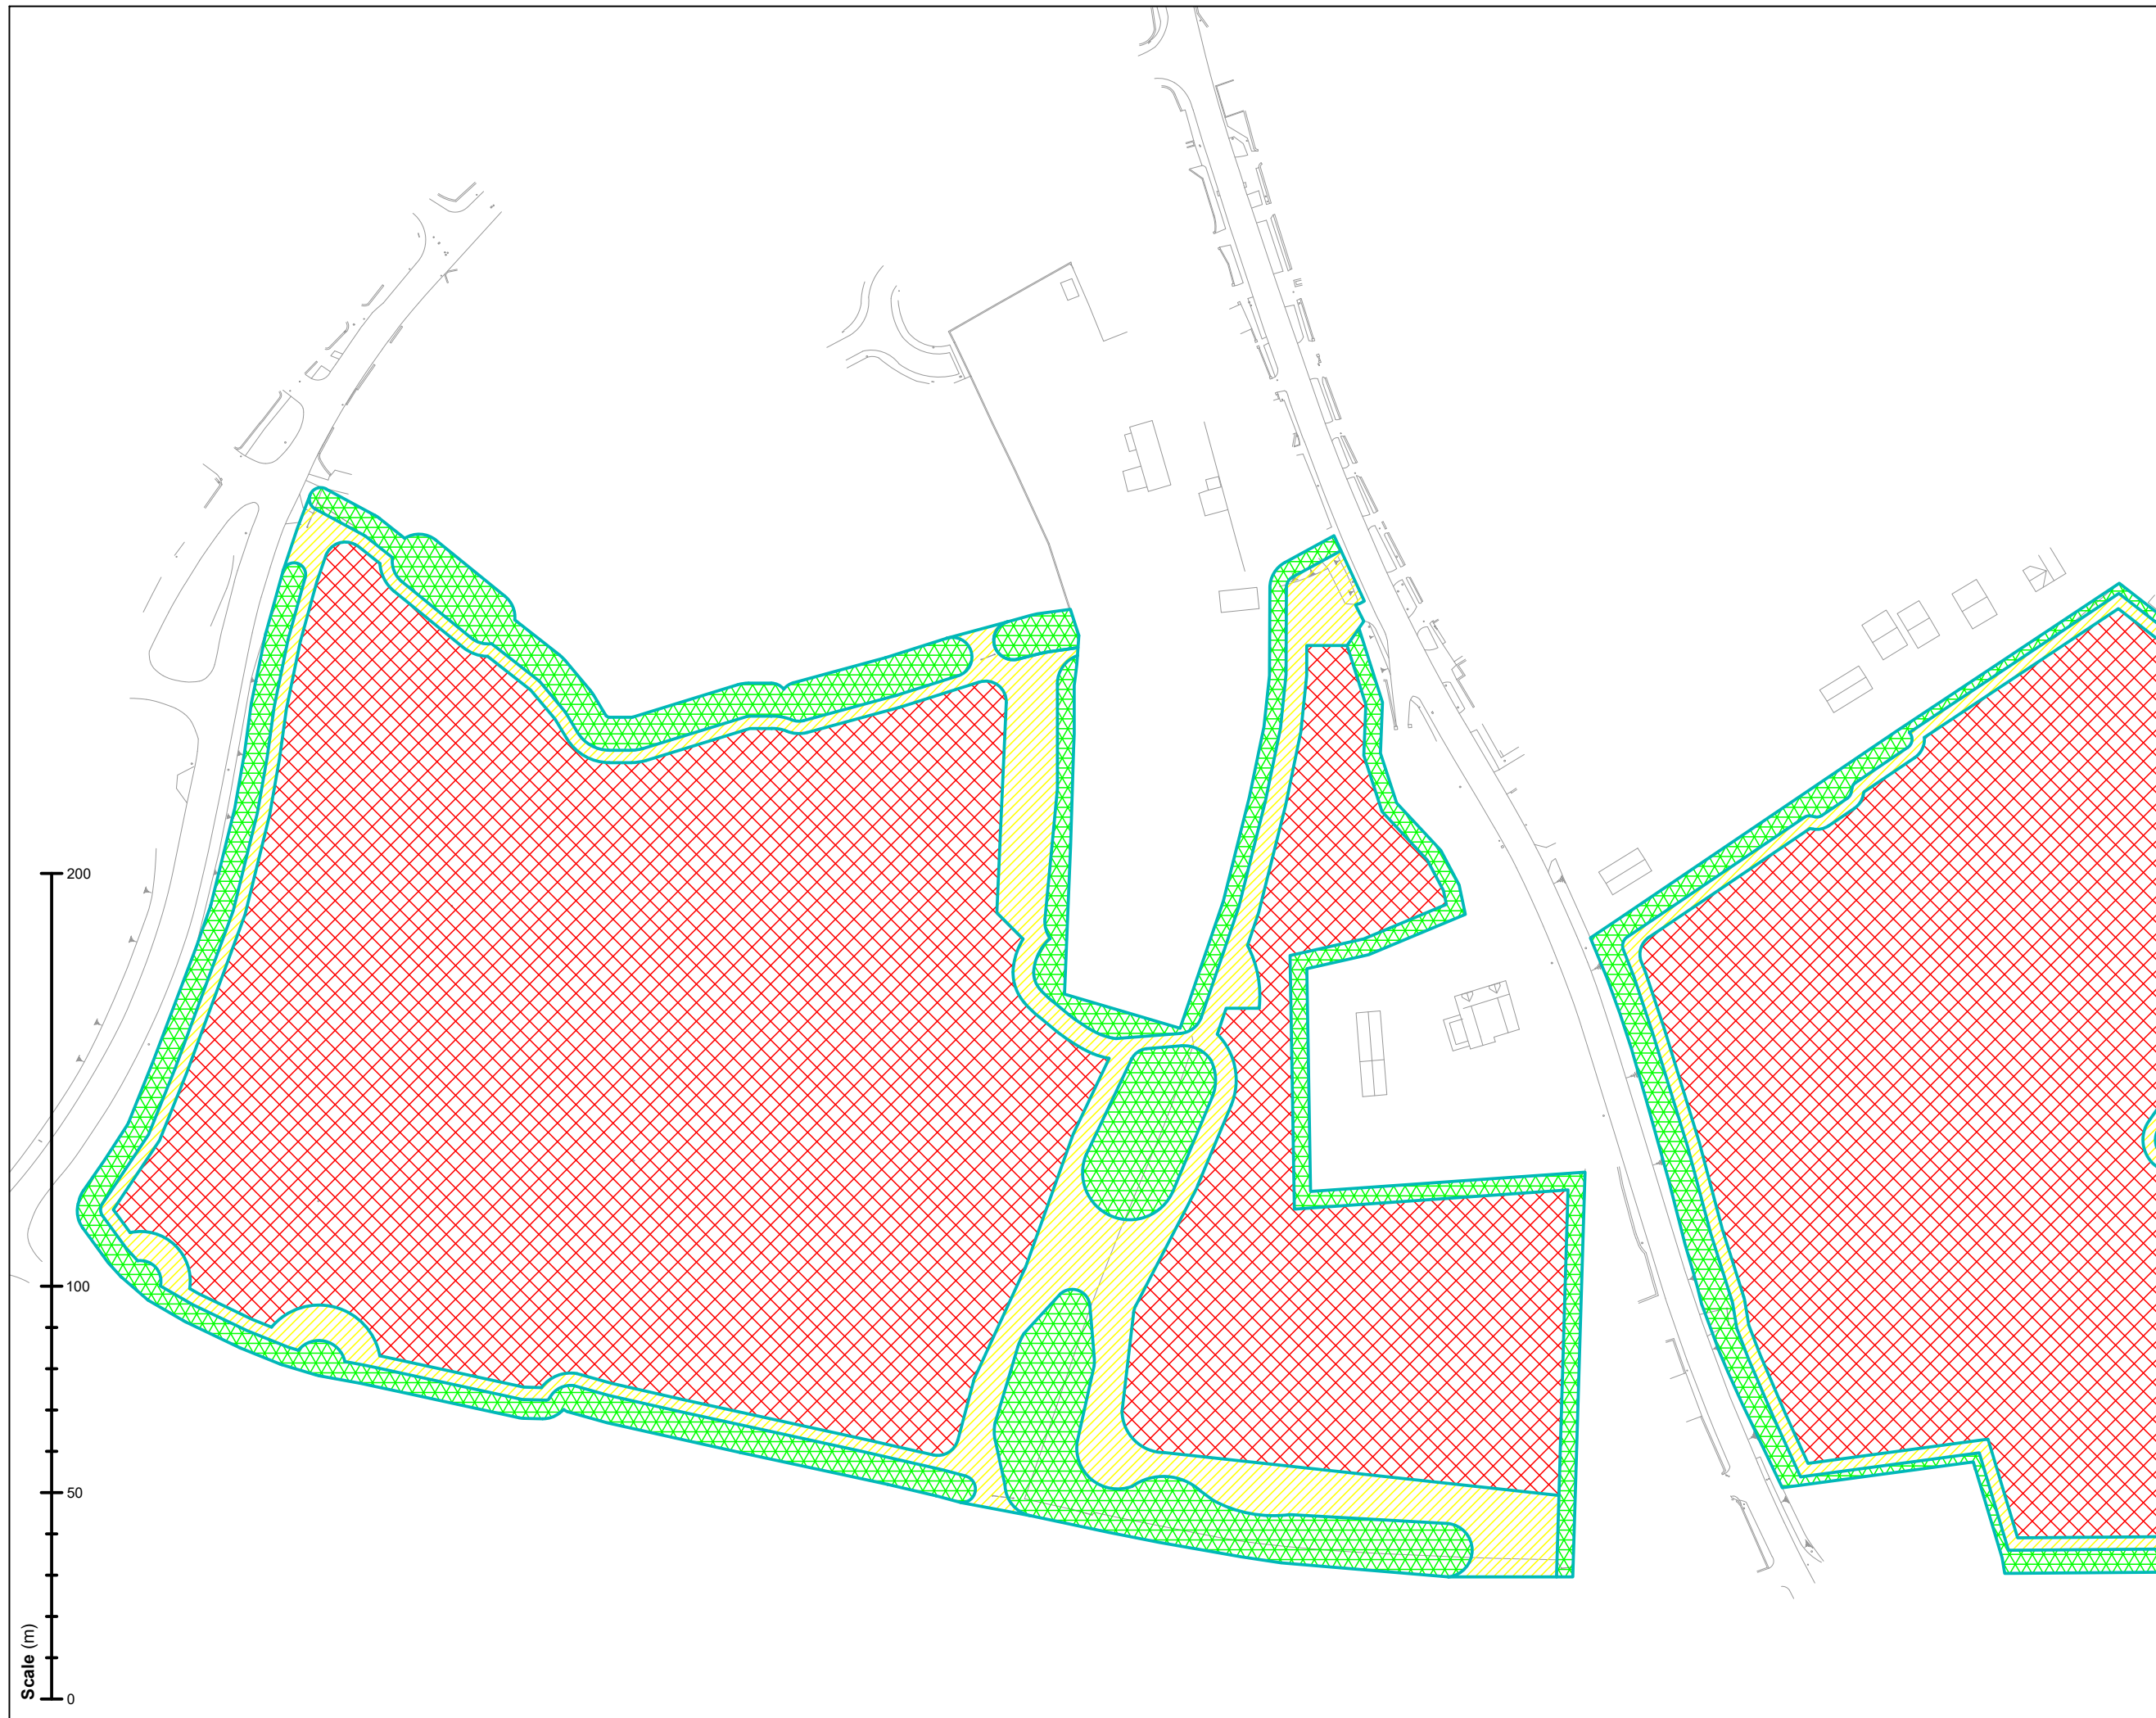
Drawing Title:
Potential Development Zones Plan (West)

3.10 Potential Development Zones – Occupied Structures

- The main areas which are suitable for occupied structures are located within the boundaries of the individual fields. In the case of the two westernmost fields, these have been incorporated into a single area as hedgerow H14 is not considered to be worthy of retention in the context of any new development.

- The area to the east of hedgerow H11 is relatively small but there is still considered to be the potential for the construction of dwellings in this parcel of land, subject to other inevitable site constraints.

- Whilst hedgerow H8 is a relatively good quality feature, its retention would potentially constrain a significant degree of design flexibility. Given the poor quality of areas A2 and A3 on either side, and the need to provide highway links throughout any development, this section of hedgerow will almost certainly lose any conservation corridor value; its removal can therefore be justified subject to the realisation of effective and flexible design which could be achieved accordingly.
