4 of 8 WE00289 – Stereographic Projections

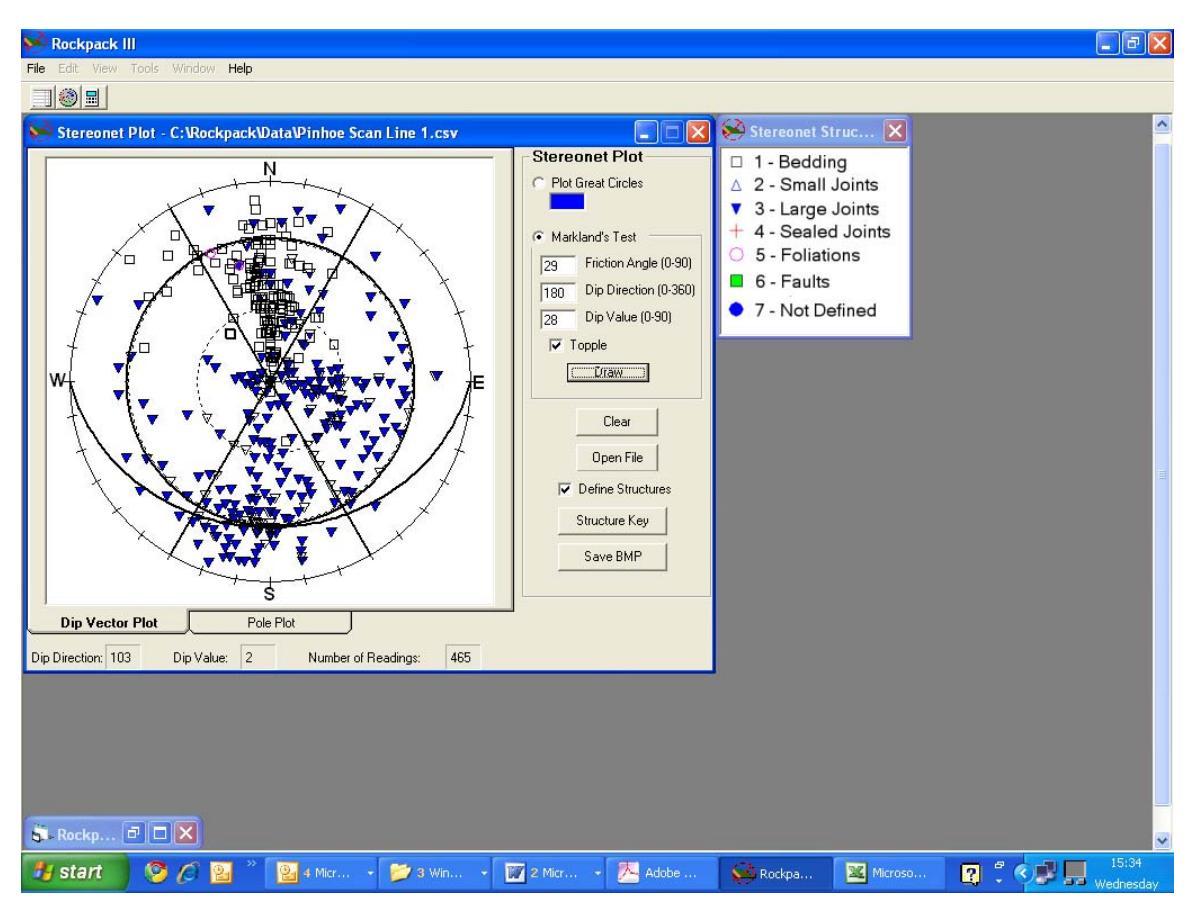
North slope dipping towards 180 degrees (south) in Shale to Sandstone ratios of 9:1 to 4:1, with a corresponding shallow slope angle of 28 degrees.

The above stereographic plot indicates the slope represented by Scan Lines 1 and Scan Line 3 has been cut to an angle controlled by the joint set dipping towards the south.

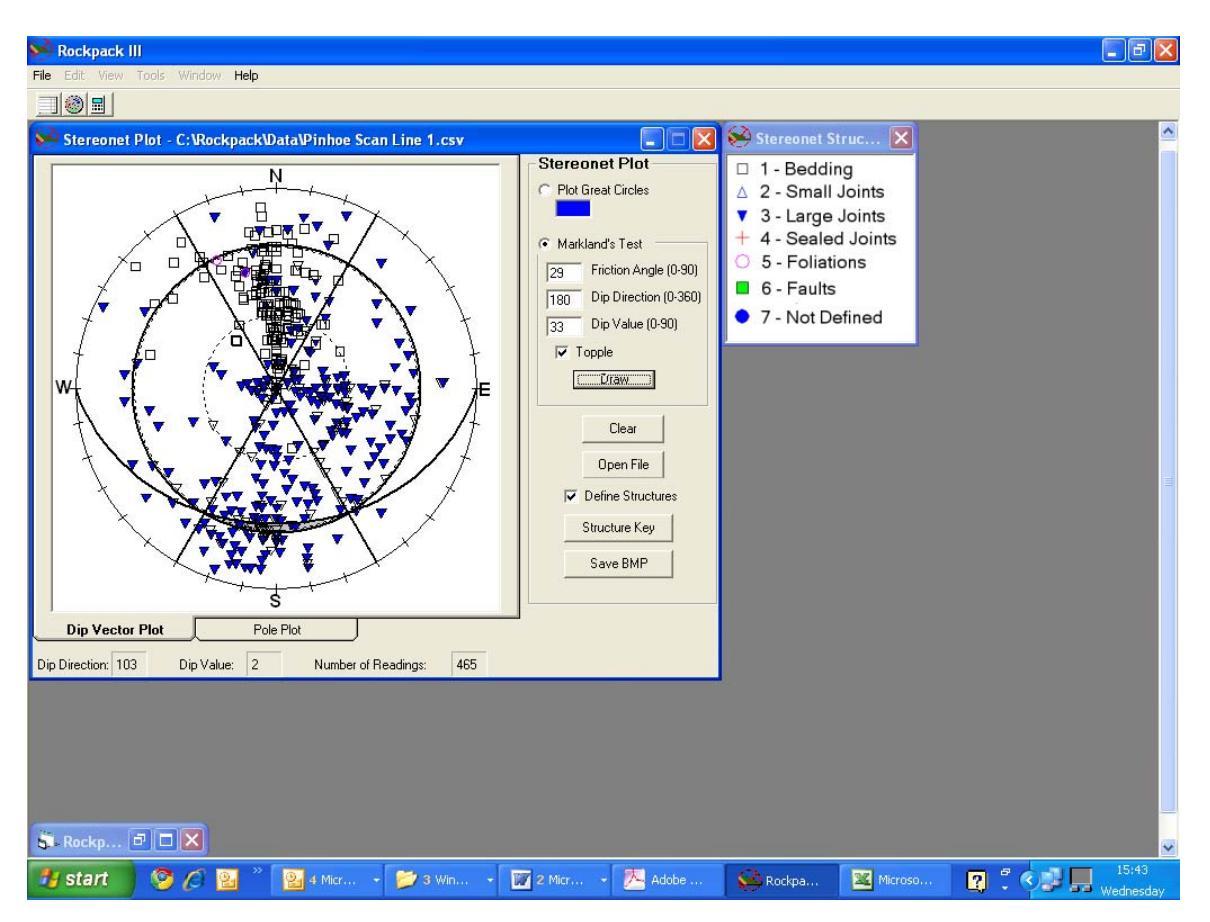
The following stereographic project shows the daylighting of joints that may result in a release surface where the ratio of shale to sandstone ranges from 9:1 to 4:1, with a steeper slope angle of 33 degrees.

The above plot provides a clear explanation or the slope angle observed in the area of Scan Lines 1 and 3.

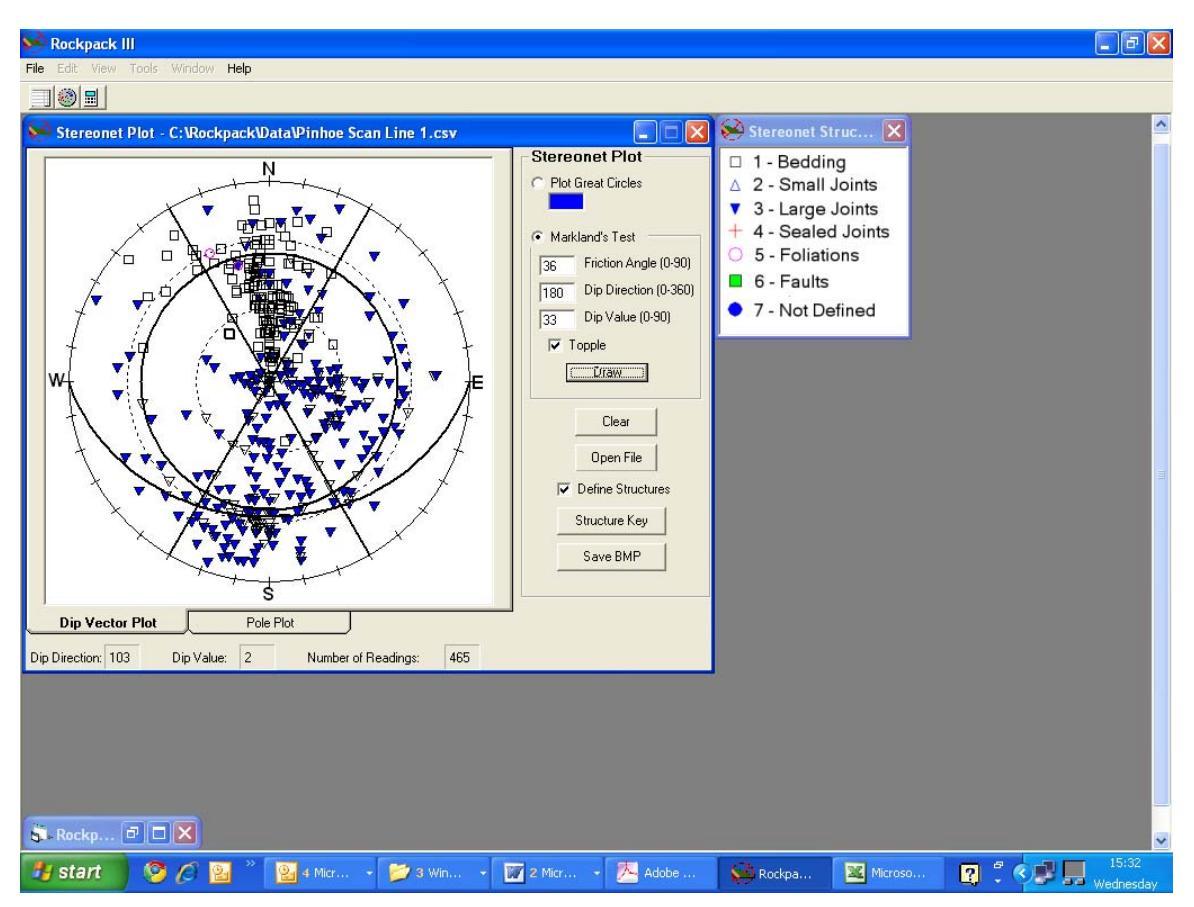
North slope dipping towards 180 degrees (south) in Shale to Sandstone ratios of 7:3 to 3:2, resulting in steeper slope angles of 33 degrees.

The above stereographic projection shows that discontinuity controlled planar failure is unlikely in the slope observed on Scan Line 4.

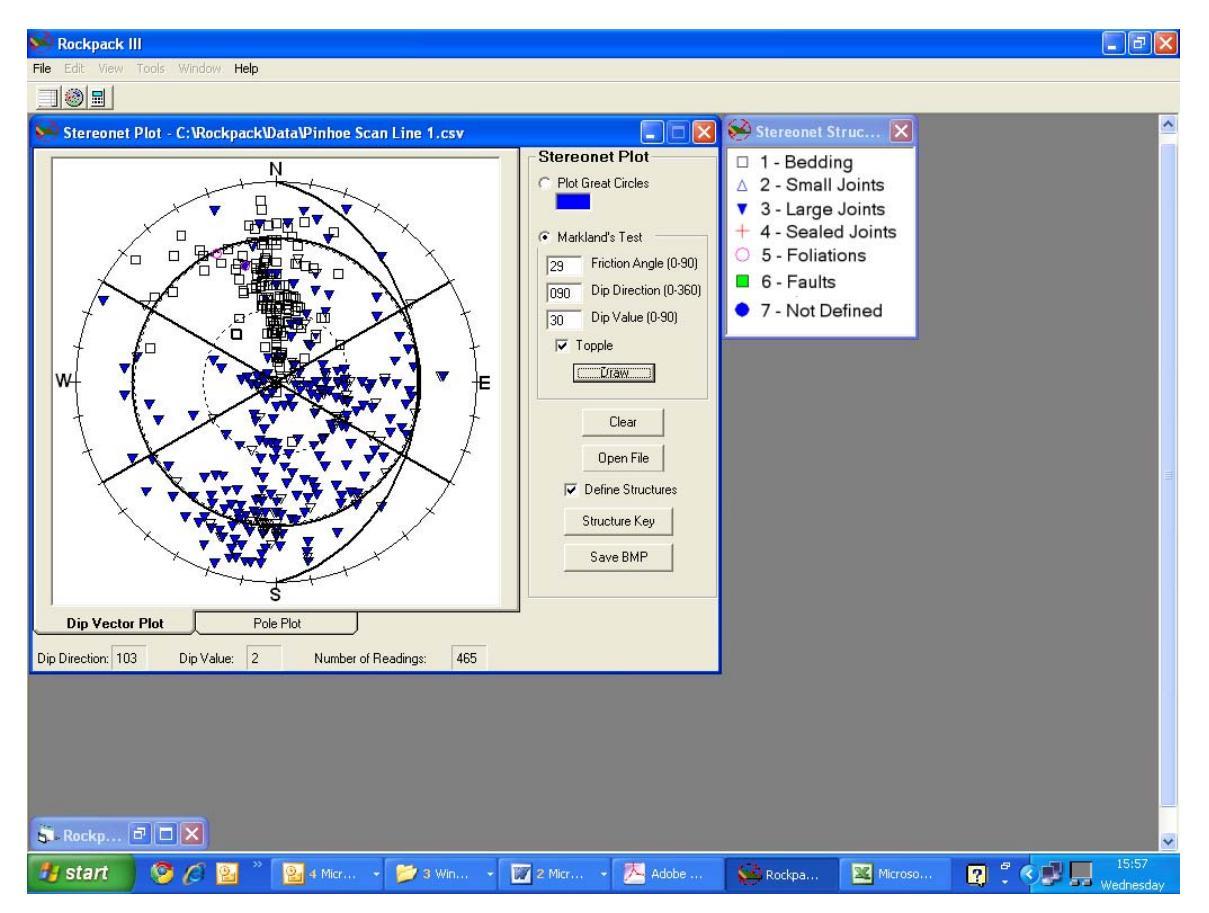
The following stereographic projection shows the likely relationship for the upper slope where the shale to sandstone ratio is 9:1 to 4:1 and the slope angle is 30 degrees.

The above table indicates the upper section of slope has been cut at the limit dictated by Joint Set 2 for the likely low proportion of sandstone.

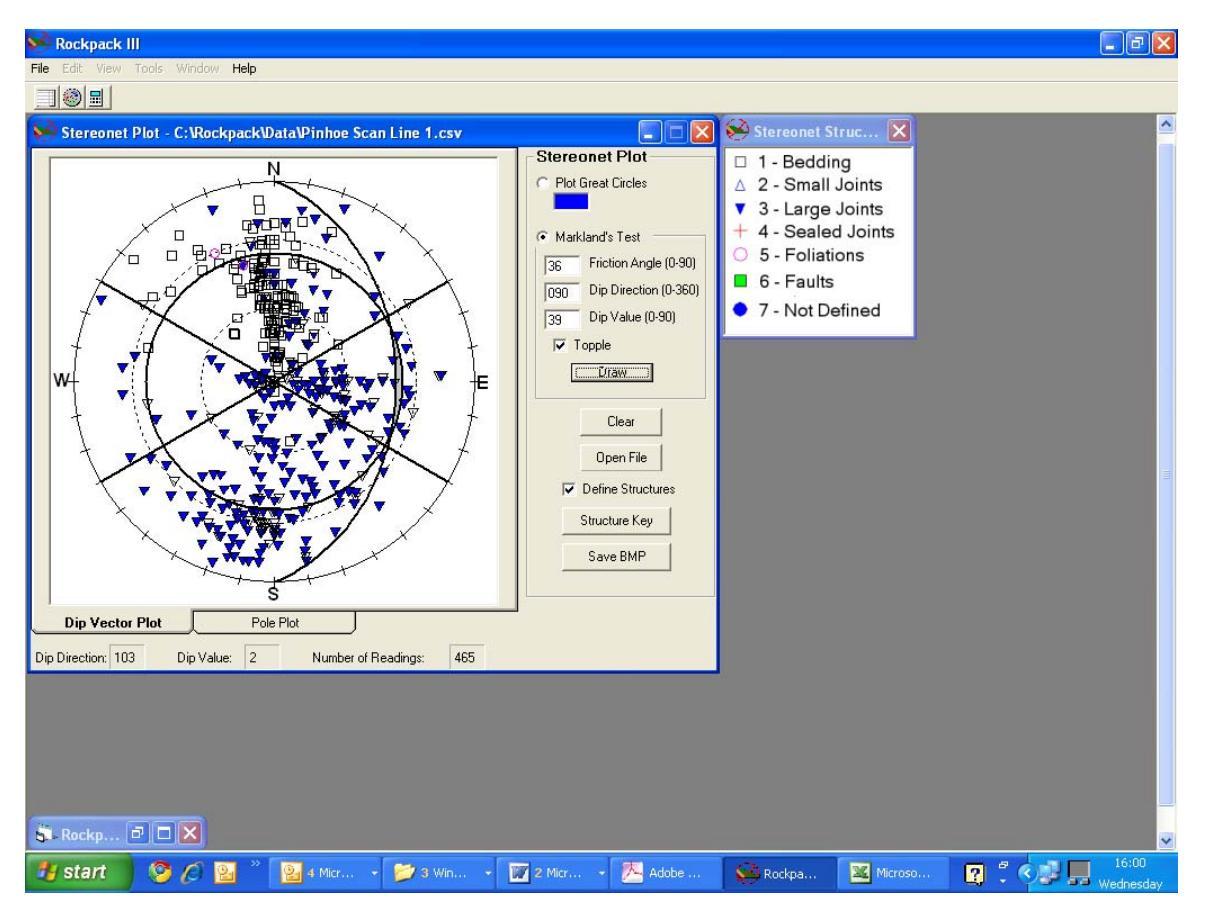
The following stereographic projection shows the likely arrangement on the mid section of Scan Line 2, where the shale to sandstone ratio is likely to enable a steeper slope angle of 39 degrees.

This section of slope is likely to be represented by a greater proportion of sandstone. The frequency of daylighting joints although plotting within the potential failure zone are fairly infrequent compared to the main cluster of steeply dipping joints.

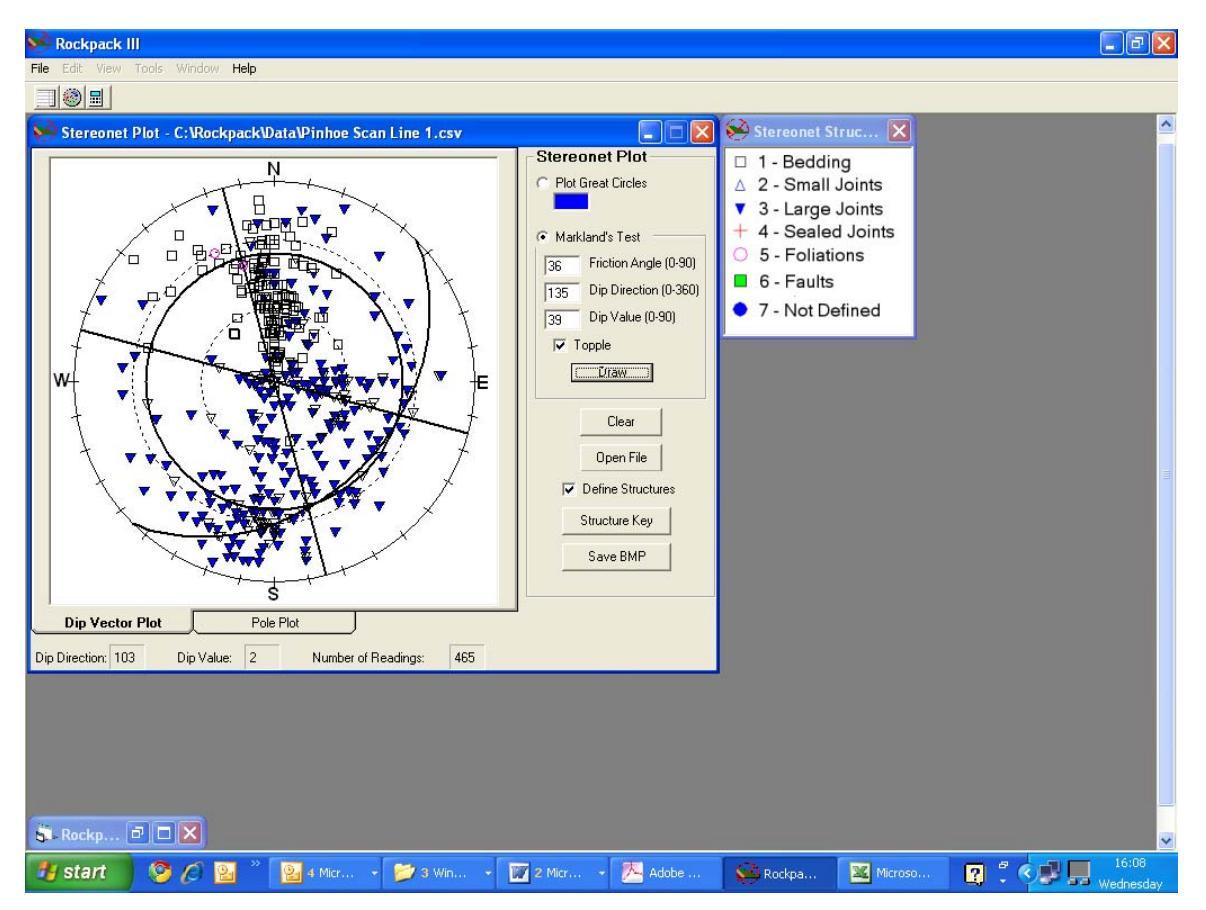
The following stereographic projection represents the west side of the quarry sloping towards 130 degrees. The existing slope is cut at a relatively steep angle of 39 degrees.

This section of slope is likely to be represented by a greater proportion of sandstone. The frequency of daylighting joints although plotting within the potential failure zone are fairly infrequent compared to the main cluster of steeply inclined joints.

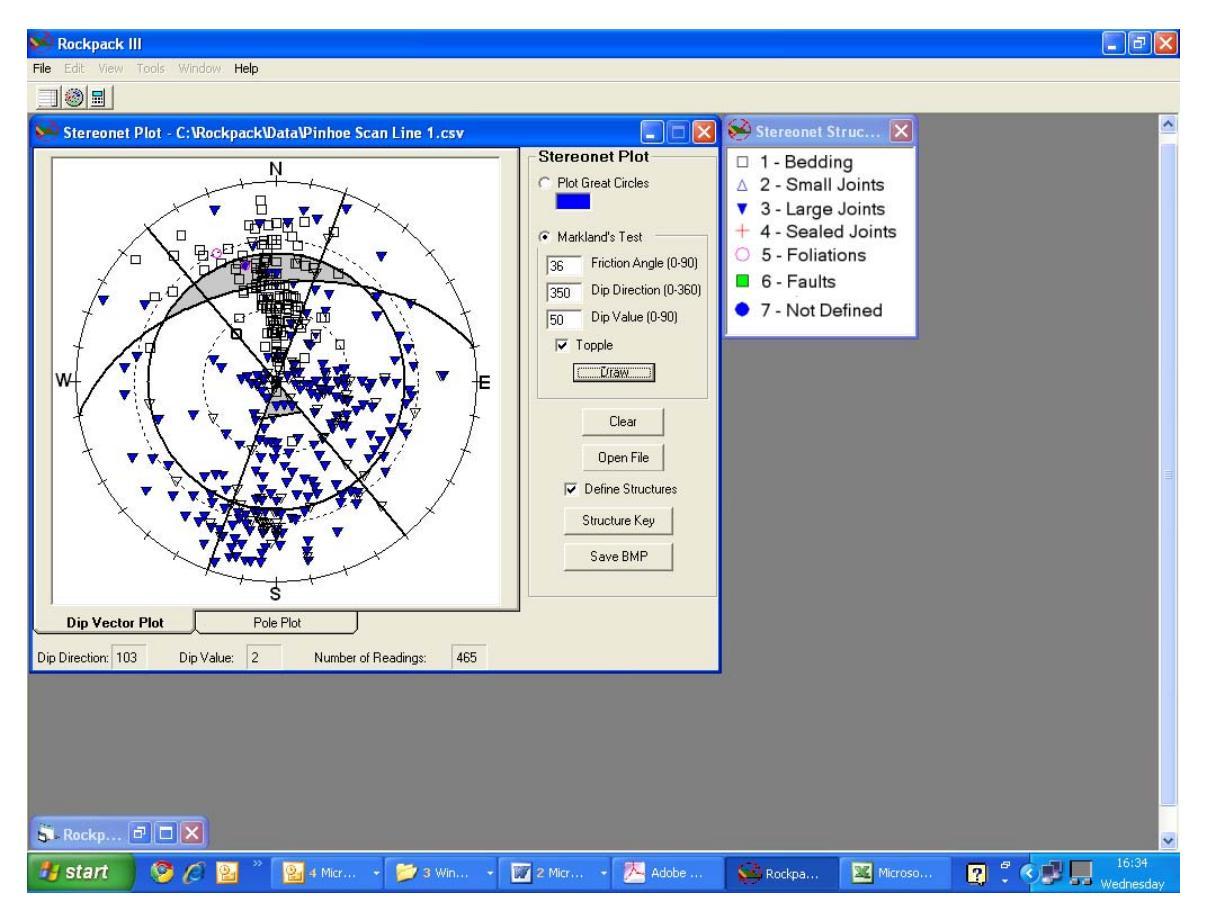
The following stereographic projection models the existing south side of the quarry, which dips towards the north (350 degrees) at a steep angle of 50 degrees.

The above plot shows the main bedding plane daylighting out of the slope. The existing slope is controlled by the inverted southern limb of the folded sandstone beds. The potential for the less steeply dipping north limbs of the fold to daylight out of the cut slope exists, if the existing cut slope is pushed further south at similar angles.
