**Carwash at No. 52 Main Road  
Pinhoe  
Exeter  
Devon  
EX4 9EY**

**Preliminary Ecological Appraisal Report  
—  
Desk Study and Protected Species Building Assessment**

**March 2022**

**Colmer Ecology Ltd  
Unit 8  
Fortescue Court Business Park  
Brampford Speke  
Exeter  
Devon  
EX5 5JN**

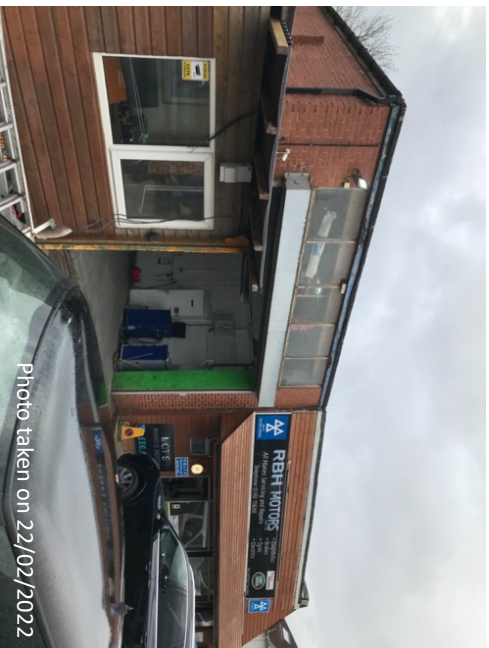
Car port and shop front with shed visible on left – note raised fascia at car port filled with cobweb and detritus

- 3.2.3 Carport: The carport was semi-detached to the shops and of tight exposed brick construction, with a blocked-up hole noted adjacent to a window at the rear. A fascia board was present only at the north-western, south-western and south-eastern elevations and generally tight, although raised along the south-eastern elevation, but filled with cobwebs and detritus. Windows were of aluminium finish and tightly fitted, affording no access points/roosting cavities for bats. Large, tight metal shutter doors were situated at the north-eastern elevation, affording no feature suitable for roosting bats. The roof was flat with tight bitumen felt lining. Internally, the carport was of exposed brick with an exposed partial metal and wooden truss. No evidence of bats was noted at the carport.

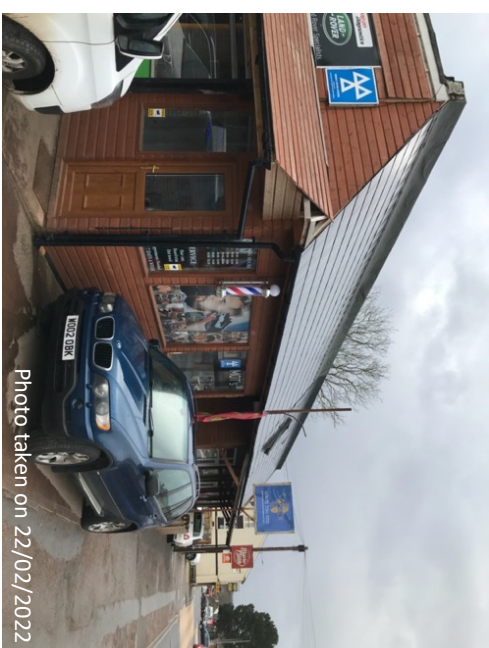
Monopitched roof section along western elevation – note area of raised cladding

- 3.2.5 A monopitched length of roof lined the western elevation of the shops/restaurant, with access noted at the top of the wall plate and with breathable membrane visible behind. At the southern end of the monopitched roof, the top of the wall plate was partially lined with a willow screen (associated with the porch of the restaurant) although access was still possible at the top of the wall plate. Access was also noted at the verges of the monopitched roof section, which was overall constructed of very tight modern slate, with a single tightly fitted Velux window noted. The ridge/join was capped with tightly fitted overhanging bitumen felt. The remainder of the roof was flat with tight bitumen felt lining.

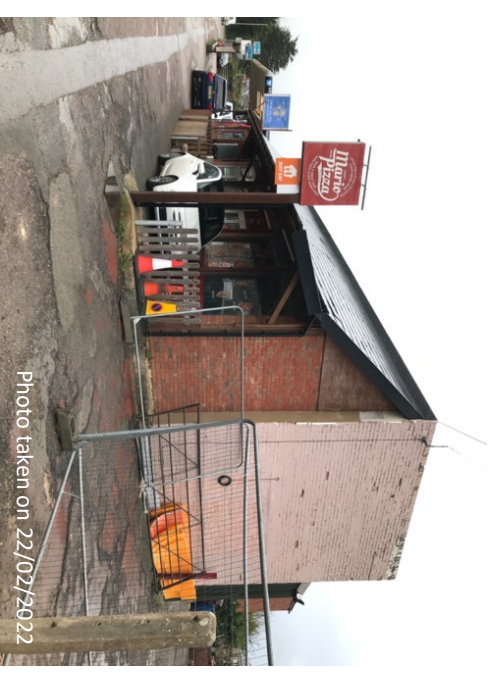
Southern elevation with exposed brick – access to monopitched loft space at verge

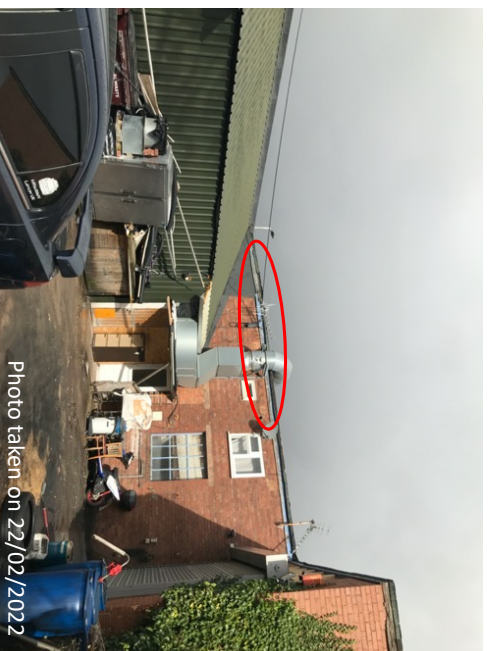
Courtyard view (back of restaurant, shop and car port) – note raised fascia with cavity (highlighted)

4.3.4 Although no evidence of bats was recorded, some areas of the shop loft could not be fully surveyed with suitable bat features and/or access points noted externally/internally. In addition, some potential was noted behind a fascia board (southern elevation of shop), as well as between wall and wooden cladding (northern elevation of shop). The Site was therefore considered to provide 'Low' potential for roosting bats i.e., *'a structure with one or more potential roost sites that could be used by individual bats opportunistically...unlikely to be suitable for maternity or hibernation'* (Collins, 2016). As the presence/likely absence of bats could not be confirmed, a **further Stage 2 bat presence/likely absence survey was recommended**. The survey will consist of a single bat emergence survey within the optimal **survey window of May – August** to confirm a negative for bats. If no bats were recorded emerging, suitable survey effort would have been conducted and the Site would not be considered a bat roost. However, if bat(s) were recorded emerging **further Stage 2 bat roost characterisation surveys will be required** comprising an additional two emergence surveys (or one emergence and a pre-dawn re-entry depending on conditions) to characterise the roost. These further bat surveys will be necessary to classify the bat roosts(s), provide suitable mitigation and determine whether the favourable conservation status of the bat species roosting on Site will be maintained based on the development proposals.

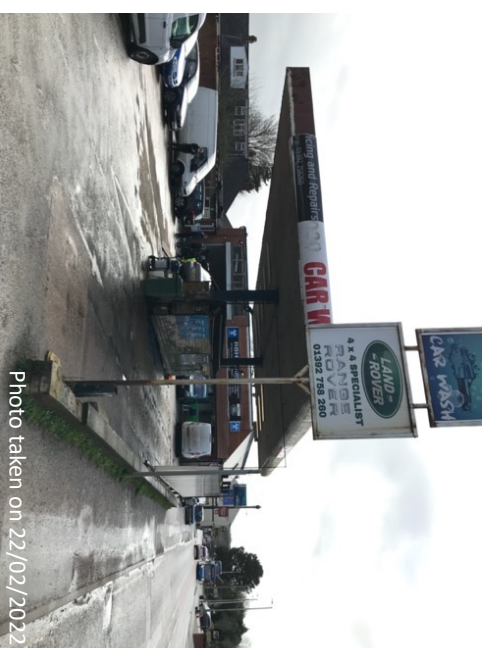
Carwash area with old petrol station canopy

3.2.8 Car wash: The car wash comprised an old petrol station canopy of corrugated metal. Some access points were noted at an overhang, forming possible cavities, although unlikely to provide potential for roosting bats.

3.3.1 At the time of the survey, no evidence of current or past breeding birds was noted within the Site, although potential was noted at the old petrol station canopy and flat roofs, particularly for gull *Larus* species.

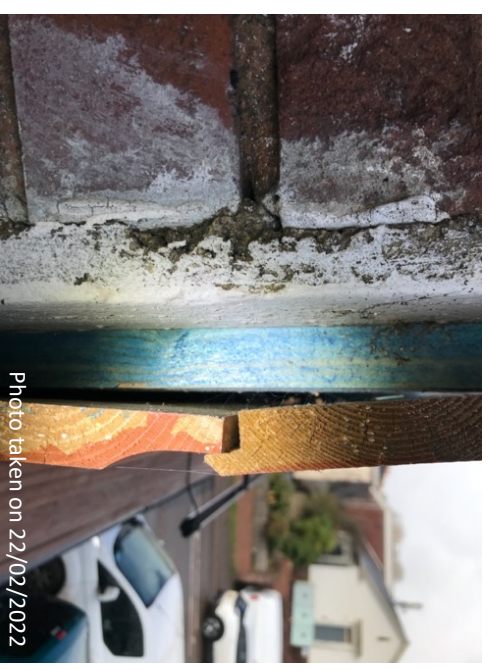
Raised cavity between brick wall and cladding at northern elevation of shop – access at the apex

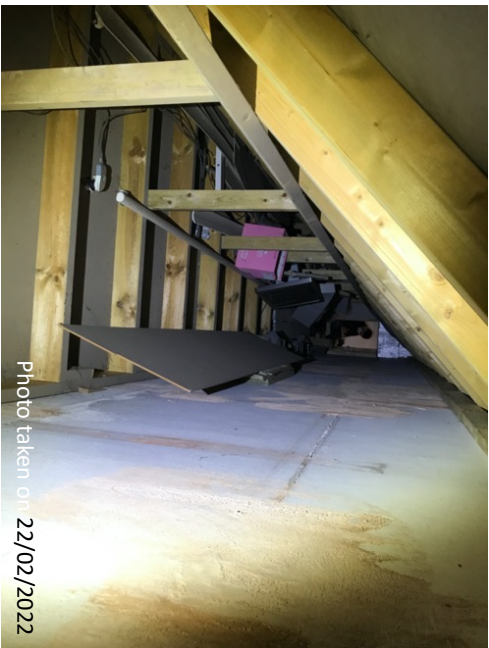
Eaves roof space, inside south-western elevation monopitched roof – note, breathable membrane lining

3.2.7 Shops and restaurant – internal: Internally, the only loft space was the monopitched section of roof that comprised eaves storage at the western elevation of the Site. The eaves space was approximately 1.6 m high and 1 m wide and accessed via a small hatch in the wall. Breathable membrane was fitted throughout and a dividing wall was noted at the western end, with no access to the other side (inaccessible section of loft space). The top of the wall plate was exposed throughout, and access was noted at the verges. No droppings were noted on the floor or walls for bats, mice or rats. A separate mezzanine floor was noted over the shop/carport and used for stored belongings and as a workshop. The truss, metal roof and brick walls were all exposed. With no evidence of bats noted.

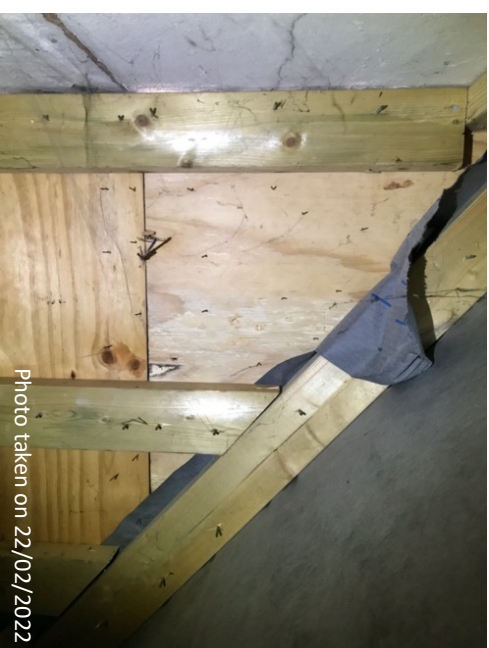
Internal wall divide inside eave space (external access at verge)

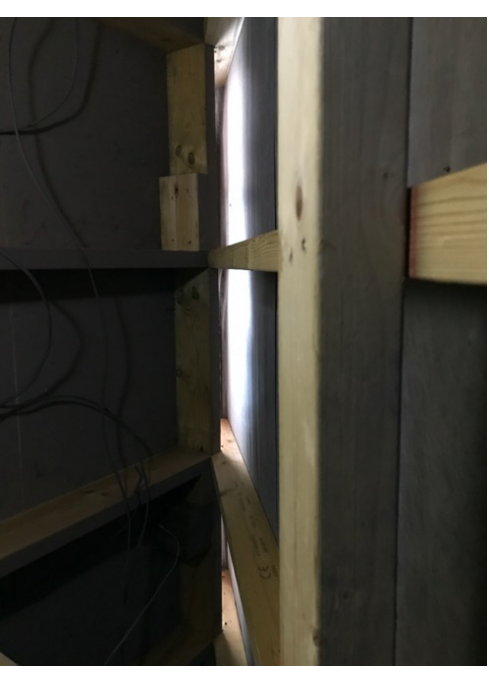
Access over top of the wall plate at porch

- 3.2.4 Shops and restaurant – external: The shops and restaurant were situated to the west of the carport. A porch was situated at the main shop entrance (north-eastern elevation) and lined with poorly fitted breathable membrane, although no cavities were noted between membrane and cladding. Access was noted at the verges of the porch, which were slightly raised. Above the porch, cladding was capped with a batten but open at the apex, affording access to the cavity behind. Cladding below the porch was slightly raised, affording access for roosting bats, although no evidence of use by bats was noted, likely due to high levels of lighting and human activity.

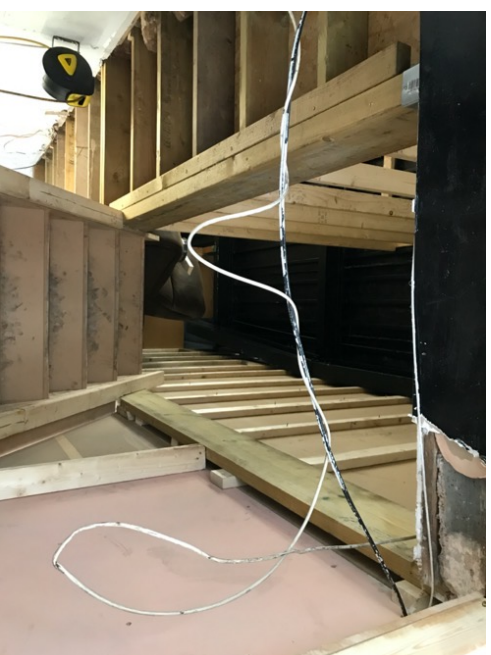
Internal access stairs to mezzanine area

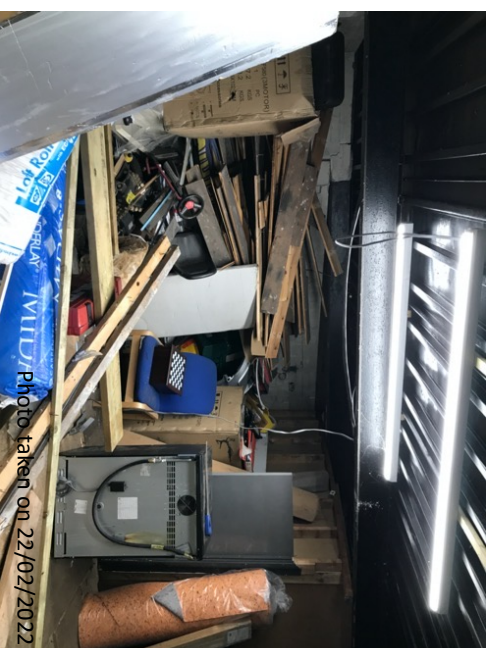
Mezzanine floor used as workshop/store area – exposed flat roof

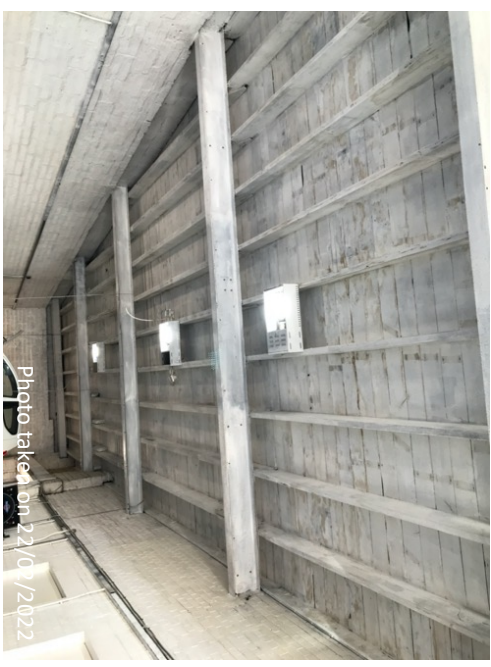
Car port interior with wooden roof structure and exposed brick walls
