**Plots 1, 2, 3, 4, 5, 8, 9, 12 & 14 Water  
Lane, Exeter**

**Interpretative Desk Study Report**

**August 2023**

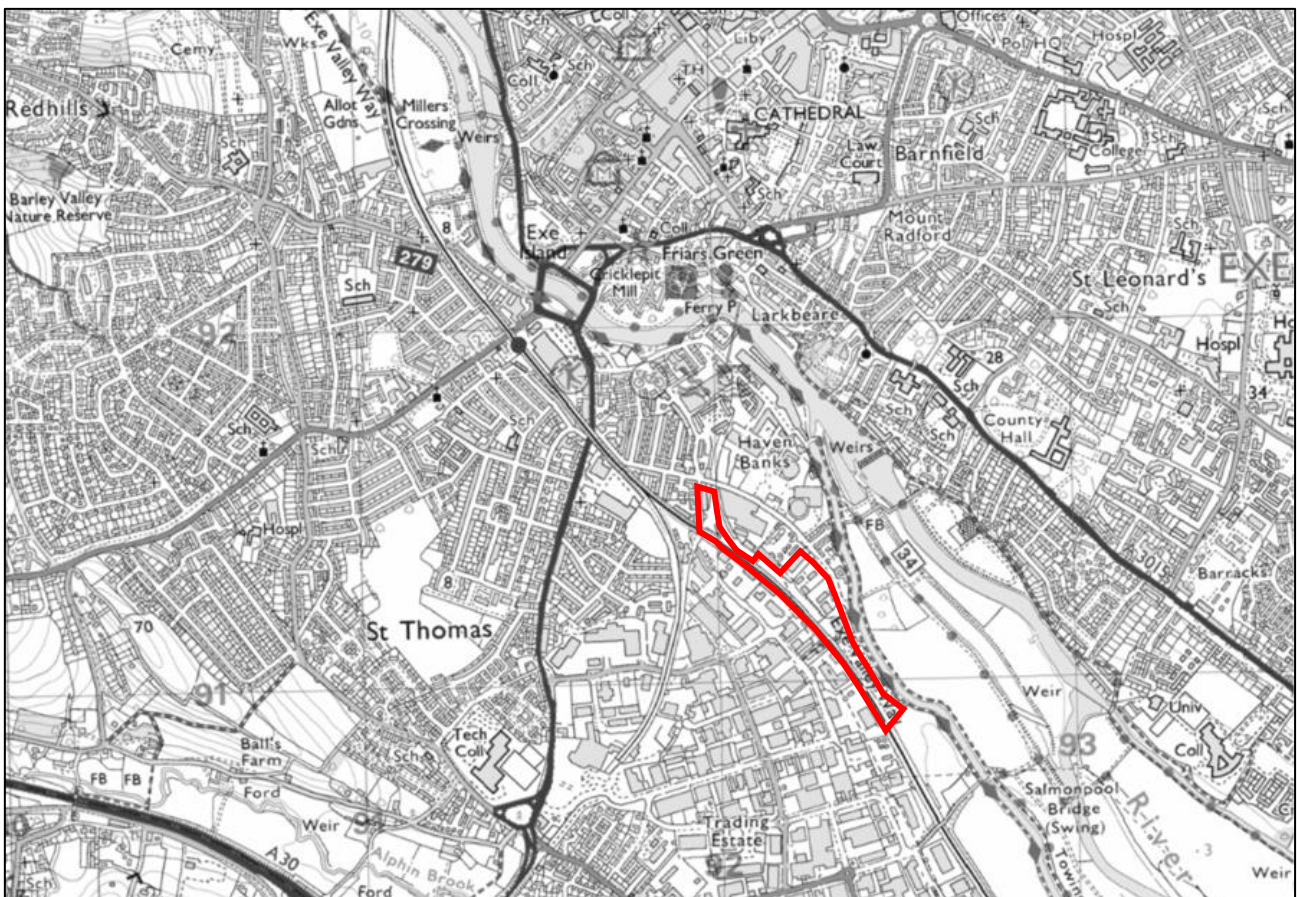
**Figure 2.1 Site Location**

The site is located off Water Lane, to the west of the Exeter Canal and approximately 1km south of the centre of Exeter. The site is divided into a number of plots which generally reflect current land uses. The site is approximately centred on grid reference 292140 091330. The site location is shown in Figure 2.1 and the site layout, including the plot reference numbers, in Figure 2.2.

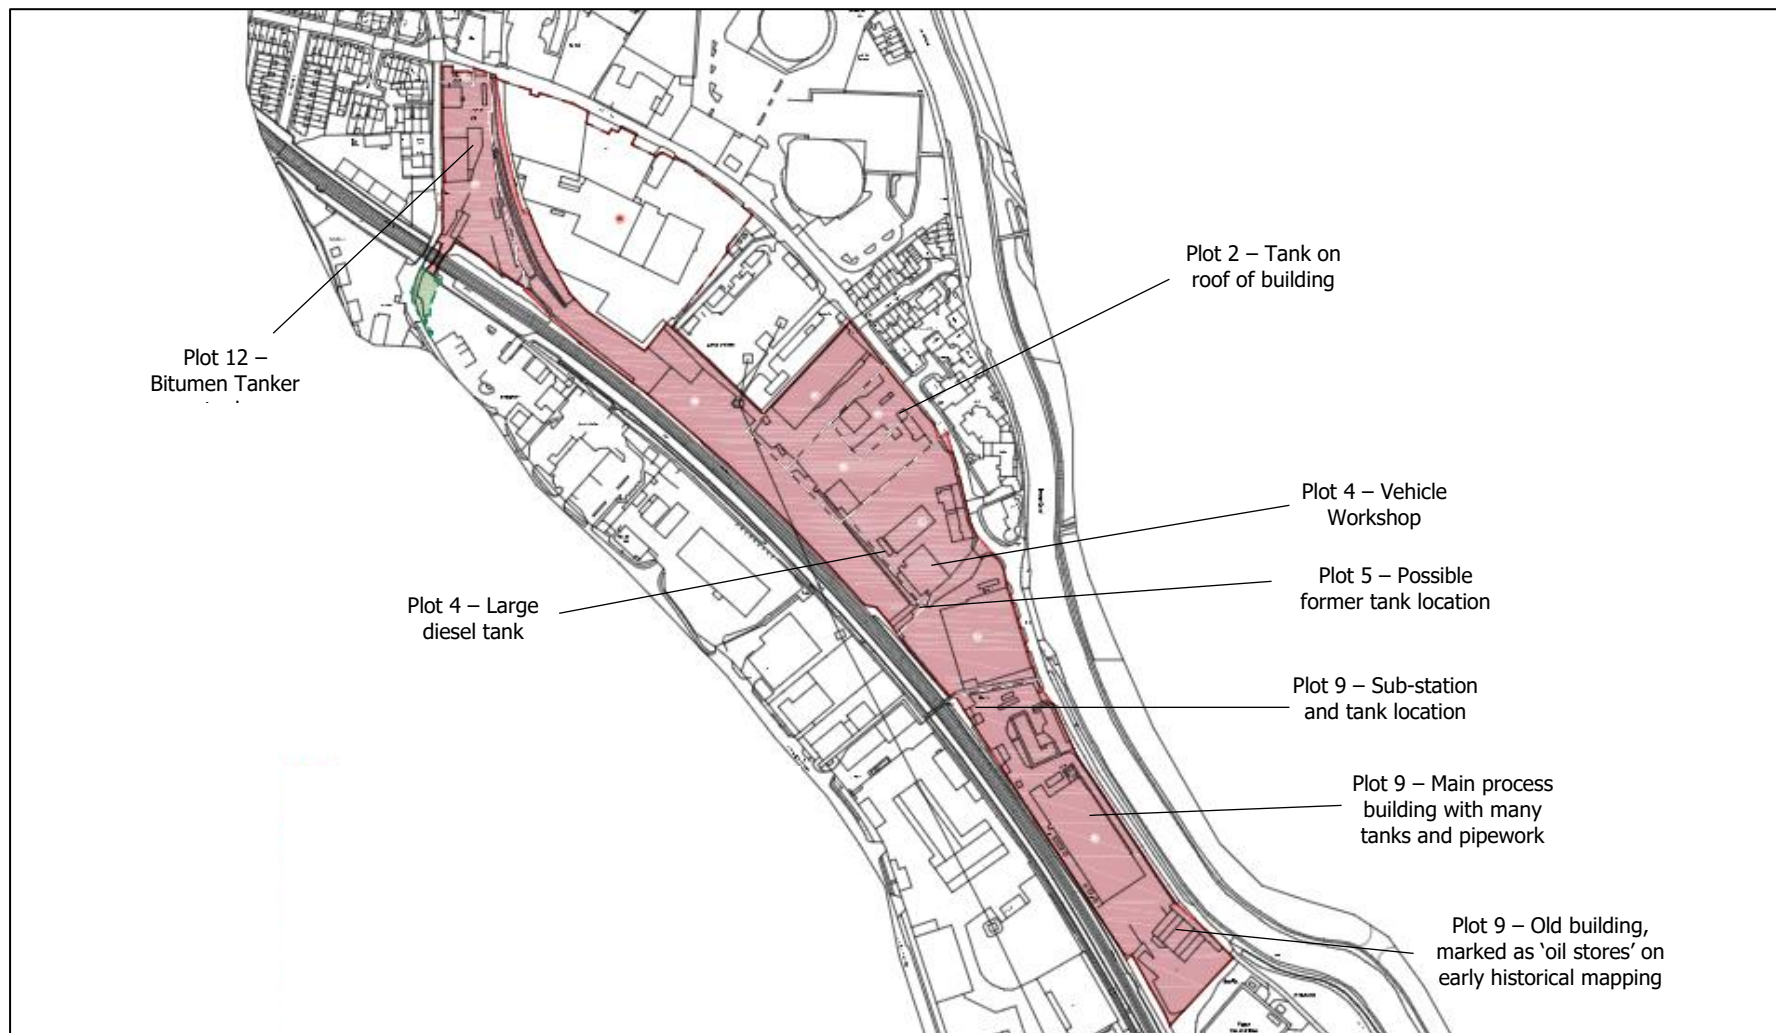
**Figure 2.3 Main Site Features**

Figure 2.3 shows the locations of some of the main features identified by the site inspection.

On the south-western side of the shed is a large above ground metallic diesel tank, from which an above ground fuel line runs to the north of the shed to locations of former pumps, where fuel was dispensed. Currently both the tank and pipework look in reasonable condition, although there was evidence of staining on the tank, along the pipe-run and at the pumps.

In the north of the plot, close to the entrance, is a small portacabin and weigh bridge. In the north-western corner is an electricity sub-station, adjacent to which is a metal tank (contents unknown) and a concrete bund within which were concrete blocks which were likely the bases of former tanks.
