Gladstone Road, Exeter

Ecological Appraisal

March 2020

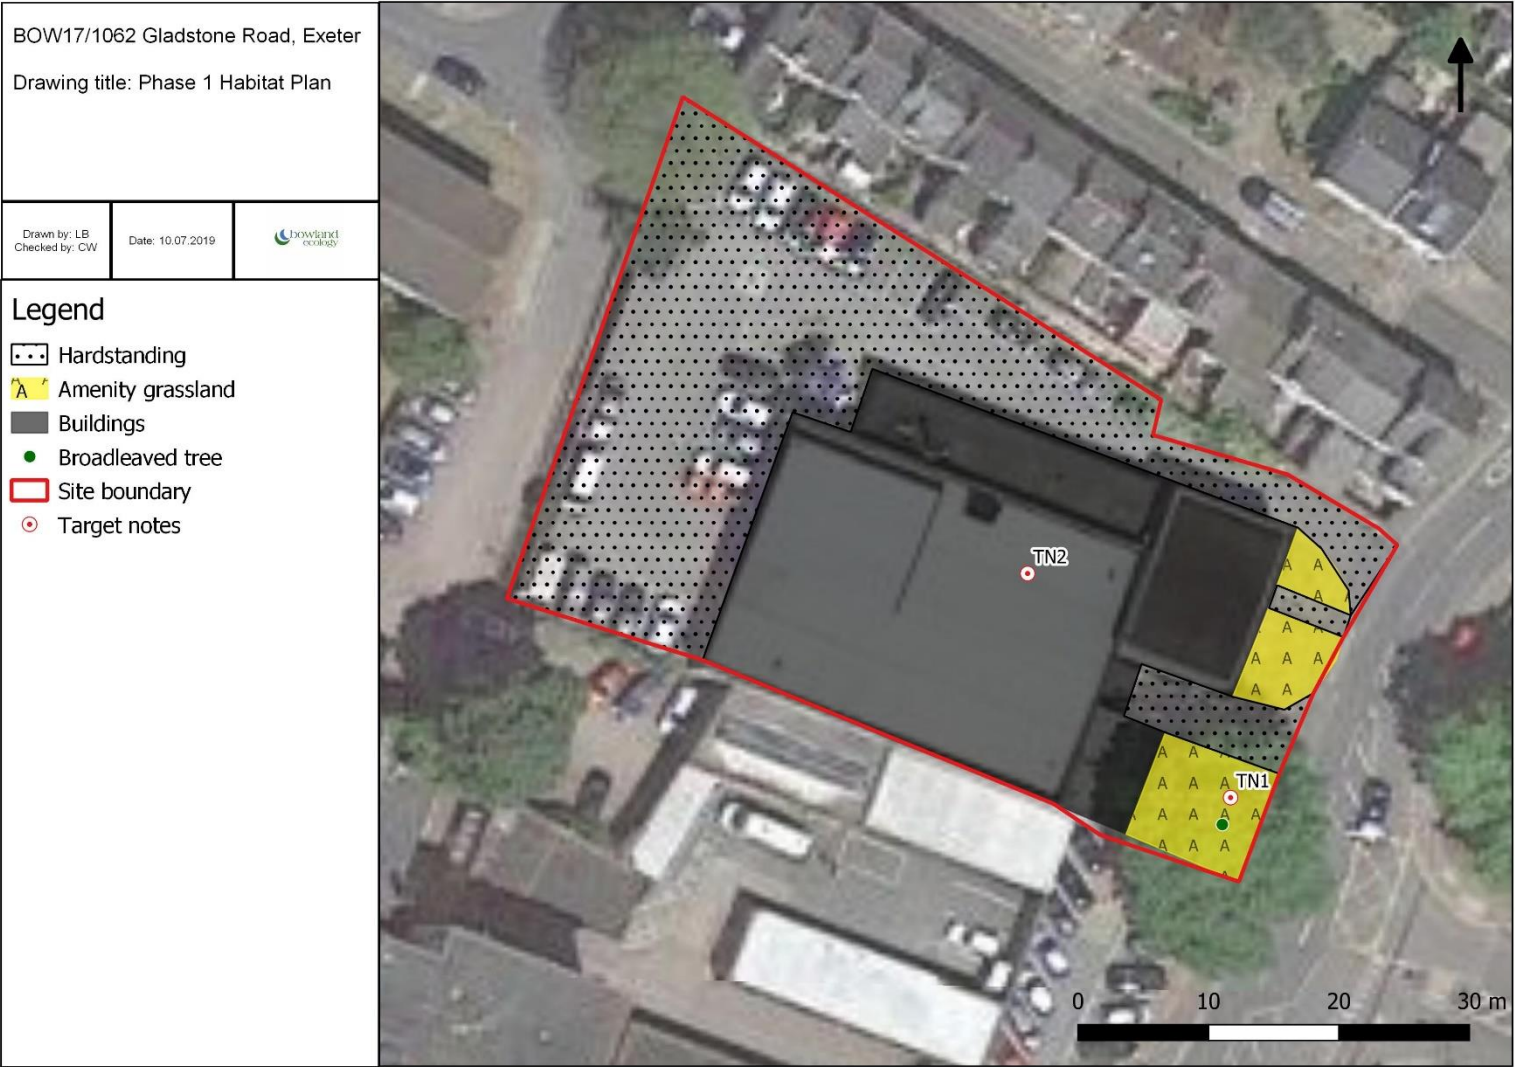
Appendix B – Phase 1 Habitat Plan

- 3.4 Target notes summarising key interest features for wildlife recorded during the extended Phase 1 Habitat survey are included in Appendix C. The Phase 1 Habitat plan of the site presented in Appendix B includes the locations of the target notes. Plant species nomenclature follows Stace (2010).

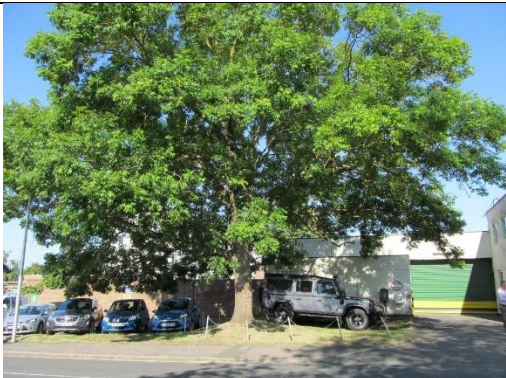
- 3.6 A single, semi-mature ash (*Fraxinus excelsior*) tree is located on the eastern boundary of the site.

- 3.16 The semi-mature ash tree was assessed as having **negligible** potential to support roosting bats due to the absence of any Potential Roosting Features (PRFs).

Target Note	Description	Photograph
1	Semi-mature ash tree at the eastern boundary of the site. The tree provides negligible potential for roosting bats and habitat for nesting birds.

- 5.2 Replacement planting at a ratio of 2:1 will be undertaken to mitigate the loss of the semi-mature ash tree. Species planted will be native, appropriate to the locality and berry bearing. Species that could be used include rowan (*Sorbus aucuparia*), hawthorn (*Crataegus monogyna*) and blackthorn (*Prunus spinosa*).

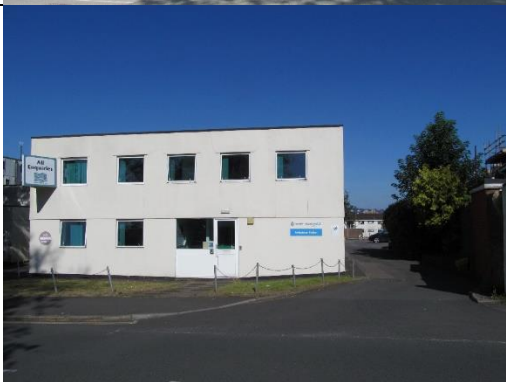
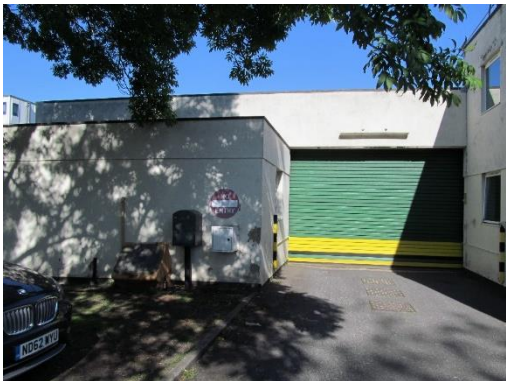
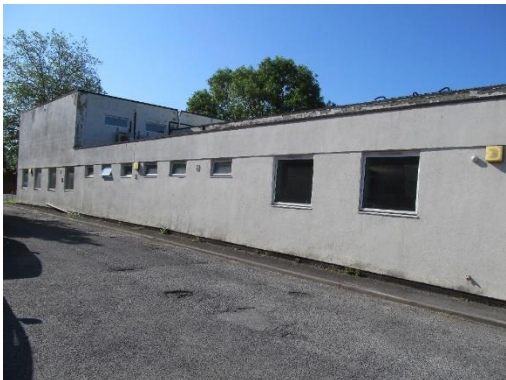
- 3.7 A single storey, flat corrugated roofed building is present on site (TN2). The eastern section of the building comprises a smaller, concrete flat roofed, two storey extension. The walls of the building comprises metal corrugated sheeting, rendered block and red brick. UPVC windows and doors are also present.

- 3.11 Externally the building (TN2) comprises rendered walls which are in excellent condition. There are no structural cracks or areas of crumbling render present. A single (former) gas pipe hole is located on the northern elevation of the building at head height (approximately 2-3 m from the ground). No evidence of bats including droppings, urine staining or grease marks was noted within the gap. The render is flush with uPVC windows and doors offering no gaps suitable for roosting bats around the frames. The render extends to the wall top cap stones and seals the wall tops on all elevations, allowing no wall top roosting potential for bats. There is a vented boiler room accessible from the northern elevation also present.

- 3.12 The southern elevation of the building comprises red brick walls which are in excellent condition. The full extent of the elevation could not be closely inspected due to the neighbouring police station building. However the majority of the elevation could be viewed from the site with close focus binoculars. The mortar is well sealed offering no potential for crevice dwelling bats.

- 3.13 Corrugated metal sheeting located at the western end of the building was found to be in excellent condition, with no gaps present in the panel joints. Due to the shape of the corrugated sheeting, there are shallow overlaps at the eaves where the roof panels overhang the western elevation. The full extent of these gaps was inspected from the ground with a hand torch and no evidence of roosting bats was noted.

- 3.14 The roof of the building is flat. The wall tops of the rendered block sections seal the roof to the wall surfaces. The roof of the western section of the building comprises single skin, corrugated sheeting. The panels are fully jointed and provide negligible roosting potential for bats.

- 3.15 The internal walls of the buildings are considered unsuitable for roosting bats as they are in current use as offices and subject to high levels of disturbance. Bats could potentially access the internal space via the roller shutter doors at the western and eastern elevations, however, no suitable bat roosting habitat is present within the building. There are no internal wall crevices, enclosed voids or cavities suitable for roosting bats. The boiler room off the northern elevation was found to be undisturbed, clean and with no evidence of use by bats. No enclosed roof voids are present within the building, and all the ceilings are suspended and sealed both inside and out. No evidence of the presence of bats was noted on any surfaces inside the building. Therefore the building is considered to have **low/negligible** potential to support roosting bats.

2	Ambulance building - single storey building with a flat roof. The walls comprise a variety of construction materials including corrugated metal sheeting, red brick and rendered walls. Internally, the building comprises suspended ceiling with no separate

- 5.3 Whilst the building was assessed as having **negligible** bat roost potential, bats are a highly mobile species and there is potential for them to utilise features within the building occasionally, at any time. Therefore, as a precautionary measure, works to demolish the building will be undertaken under Reasonable Avoidance Measures (RAMs) as described below. RAMs are considered appropriate to mitigate the risk of encountering a low number of bats within the building and reduce any encounters to a negligible level.

- Before any works proceed all contractors will be made aware of the possible presence of bats, bat field signs to look for and procedure if bats are found or discovered (see Appendix E);
- Careful timing of works is recommended. For works to conform with best ecological practice in this instance, it is recommended that any works to demolish the building are scheduled to occur within the period of least impact to bats – during the autumn (late October and November) or early spring (late February and March);
- A suitably qualified ecologist should be on call during the works and if a bat is found, the ecologist will attend site, remove the bat, check the health of the bat and then place it in a suitable, pre-installed bat box; and
- If a bat is in immediate danger it should only be picked up with gloved hands and placed in a secure container with air holes.
