58 Main Road, Pinhoe, Exeter

Ecological Impact Assessment (Bats and Birds)

September 2023

Ref: 2078-EcIA-HS

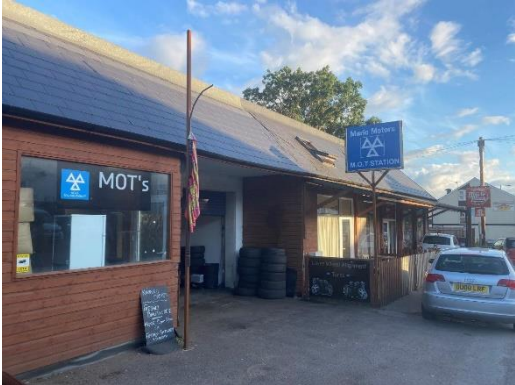
<p>Office at the north-western elevation</p>

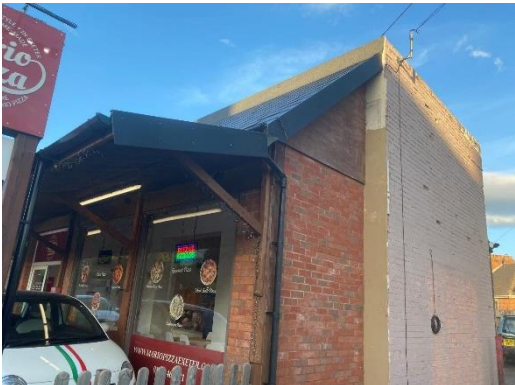
<p>Restaurant at the south-western elevation.</p>	Low

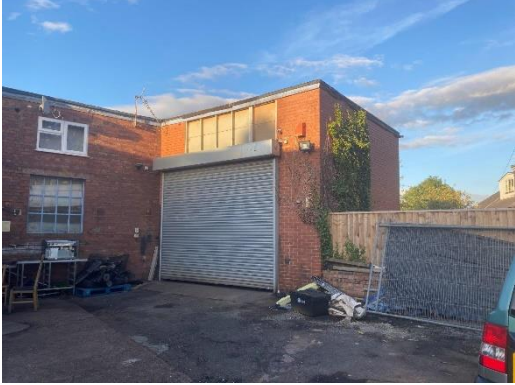
<p>Southern elevation of the car port</p>

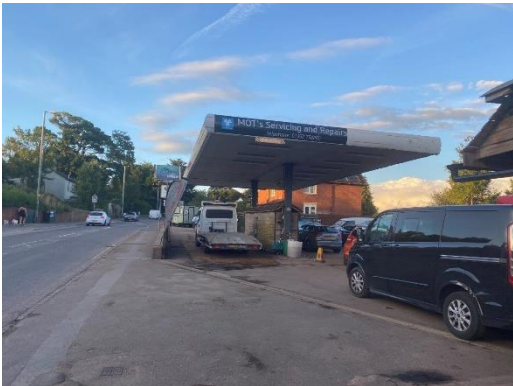
<p>2 – Carwash and shed</p>	<p>The car wash was a corrugated metal canopy over hardstanding. A small wooden storage shed was present underneath, with a corrugated rubber roof. The shed contained storage for the water pump and cleaning supplies for the carwash.</p>	<p>The carwash roof was constructed of tightfitting metal and had no bat roosting potential. Due to daily usage and disturbance the shed had no bat roosting potential.</p>

<p>View of car wash and forecourt looking north</p>

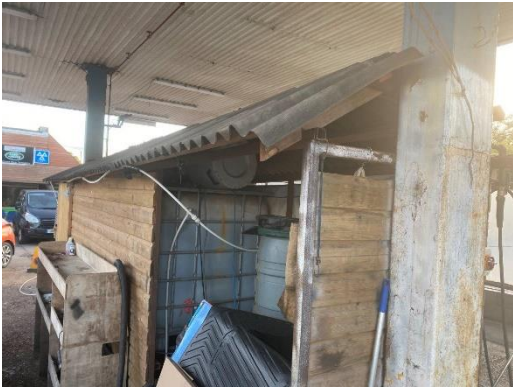
<p>Shed within the car wash</p>	<p>Negligible</p>
-----------------------------	--	---	--	-------------------

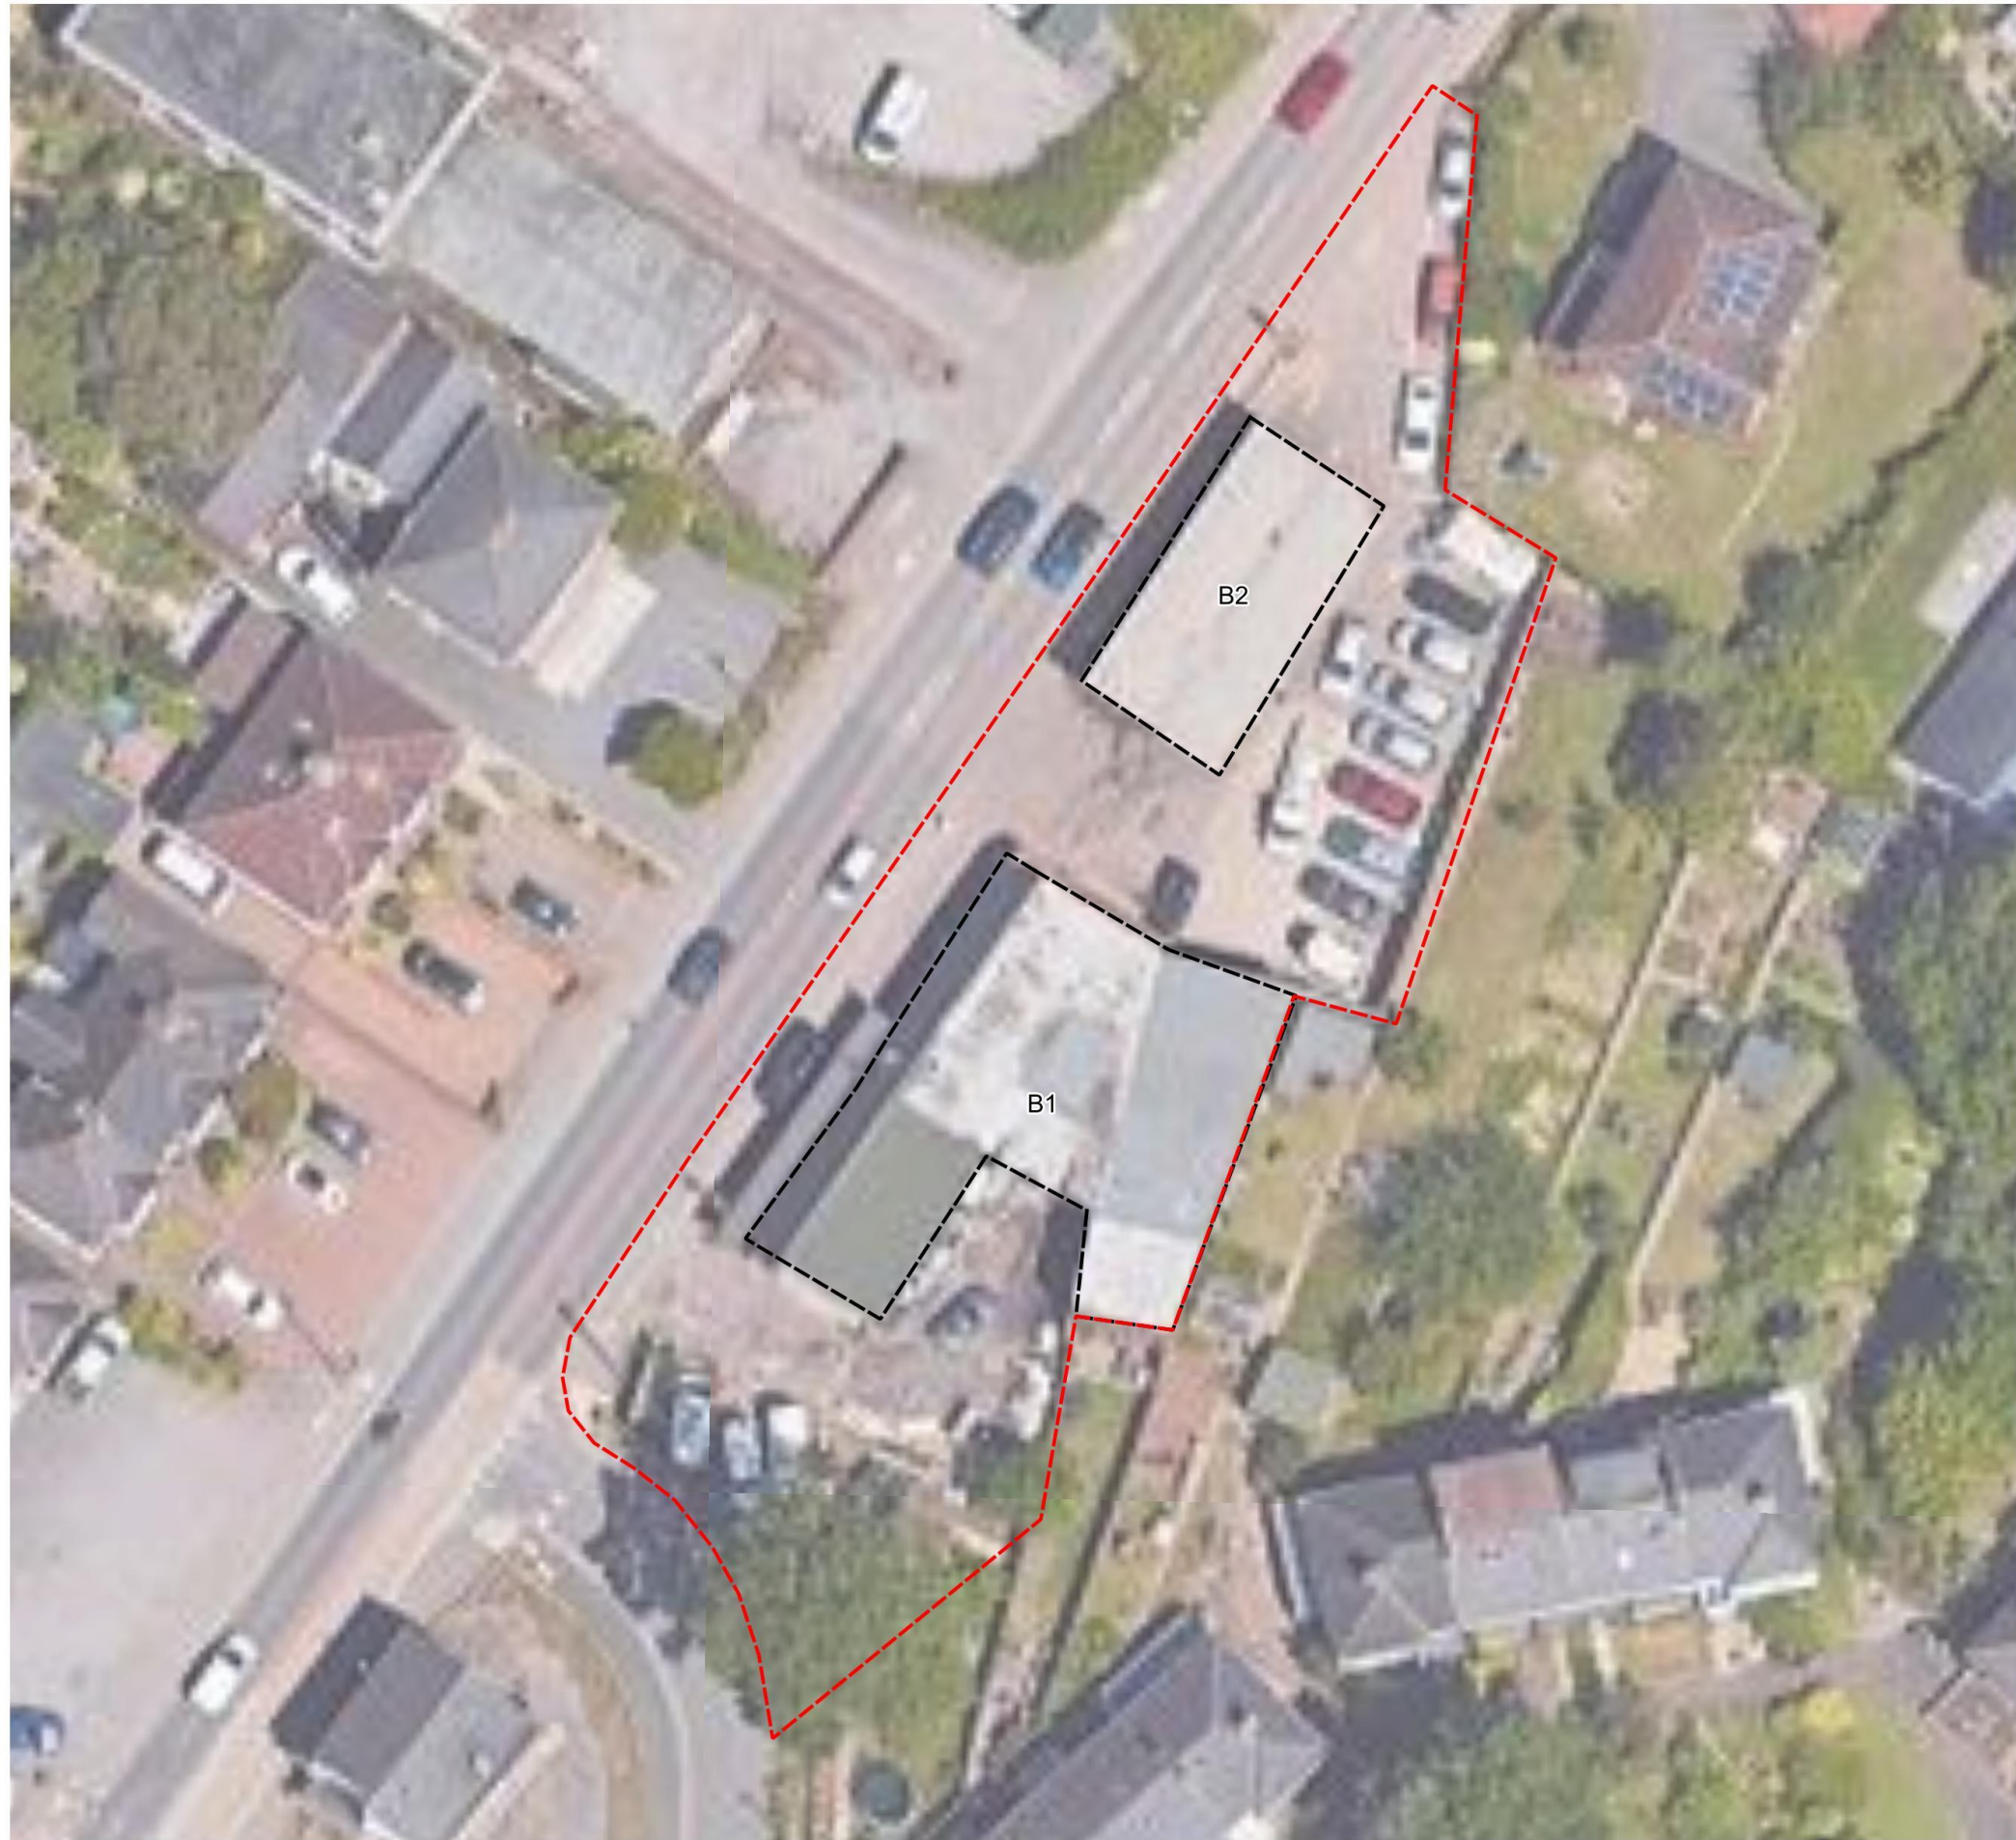
Figure 1:
Building Locations

Buildings were then prescribed a category based on their potential to support roosting bats as detailed in **Table 1**. Building locations are shown in **Figure 1**.

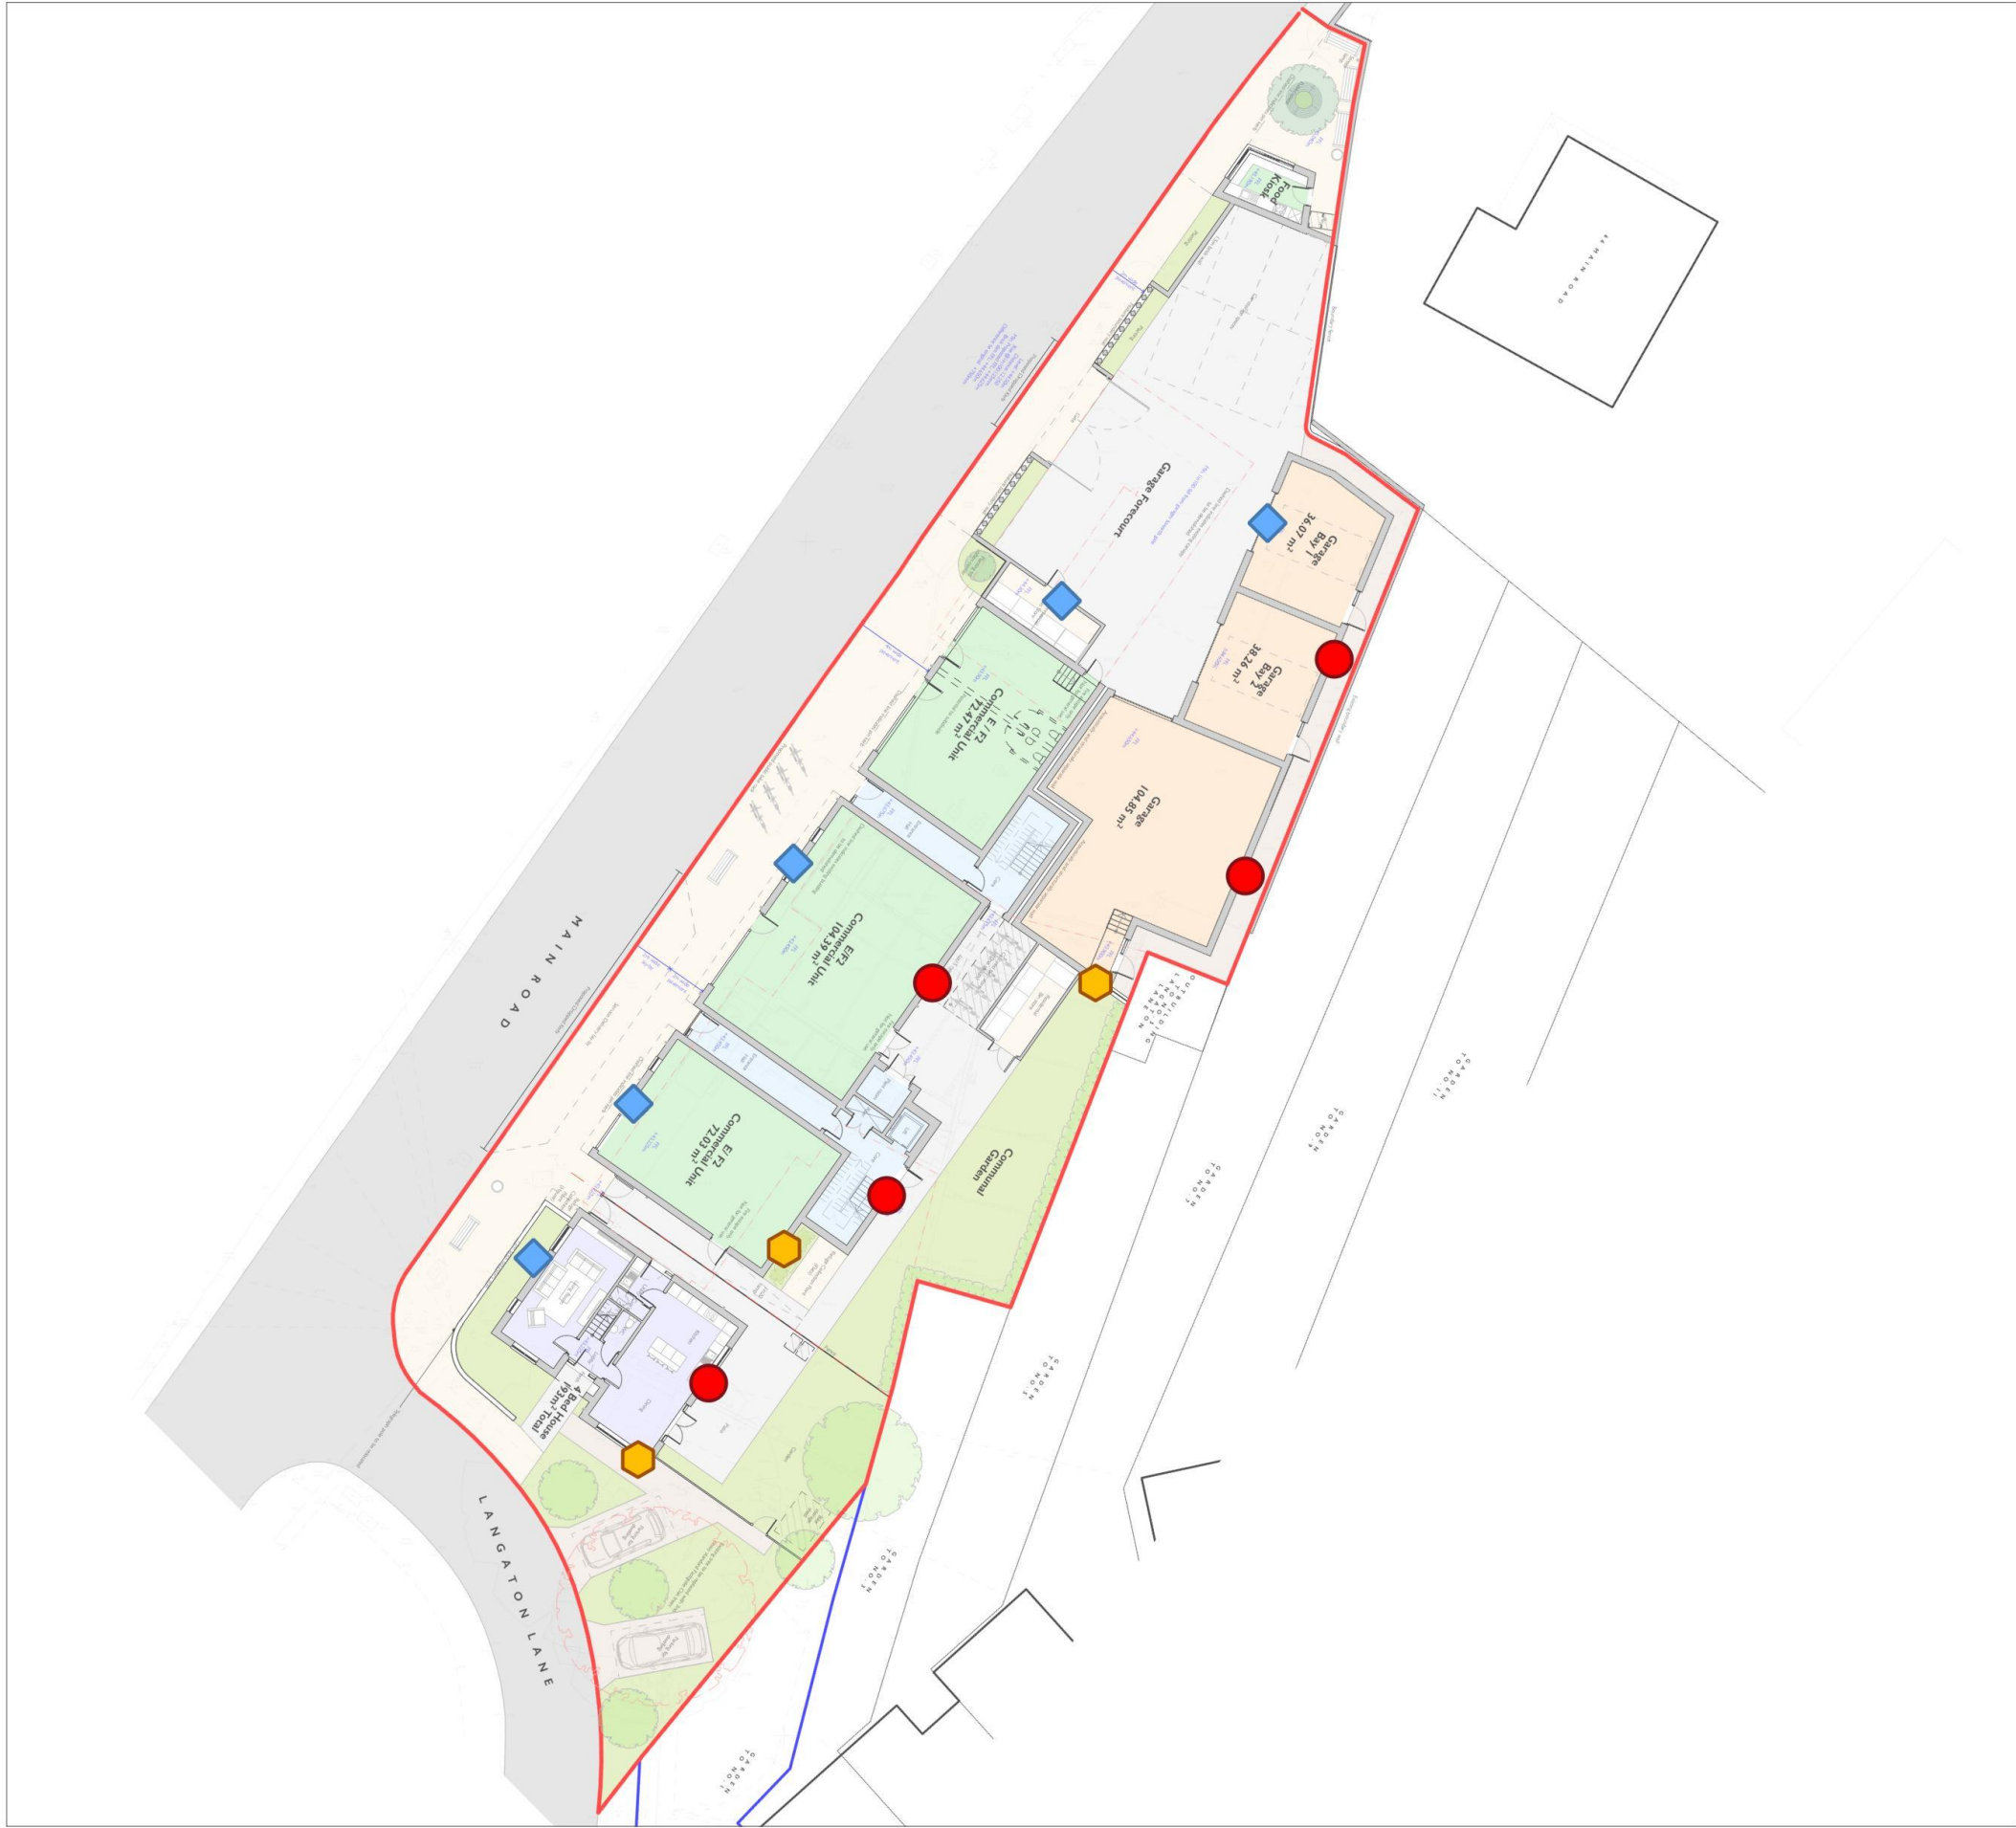
Figure 2:
Ecological Mitigation and Enhancement Plan

In line with national and local planning policy it is recommended that ecological enhancements are included in the design of the development. This may include five bird boxes, five bat boxes and three bee bricks. These could be integrally built into the brickwork during construction or fixed retrospectively. See **Figure 2** for suitable locations.

-   Bee Bricks
-   Integrated Bat Box
-   Integrated Bird Box

Bat boxes should be located high on the building (e.g. at a gable apex or the wall top), in a dark location and with good connectivity to hedgerows/ tree lines.

Boxes should be positioned on a northerly, easterly or well-shaded aspect avoiding southerly elevations and the immediate vicinity of windows. They should be erected at least 3 to 5 metres above ground level with unimpeded access, ideally directly under the eaves.

Bricks should be positioned on a southerly or westerly aspect. They should be erected at least 1 metre above ground level with unimpeded access.
