TIMBER
ASSESSMENT
RE-SURVEY

THE WELL HOUSE TAVERN
ROYAL CLARENCE HOTEL
CATHEDRAL YARD
EXETER

January 2022

DEMAUS BUILDING DIAGNOSTICS Ltd
STAGBATCH FARM, LEOMINSTER, HEREFORDSHIRE HR6 9DA
Tel. 01568 615662

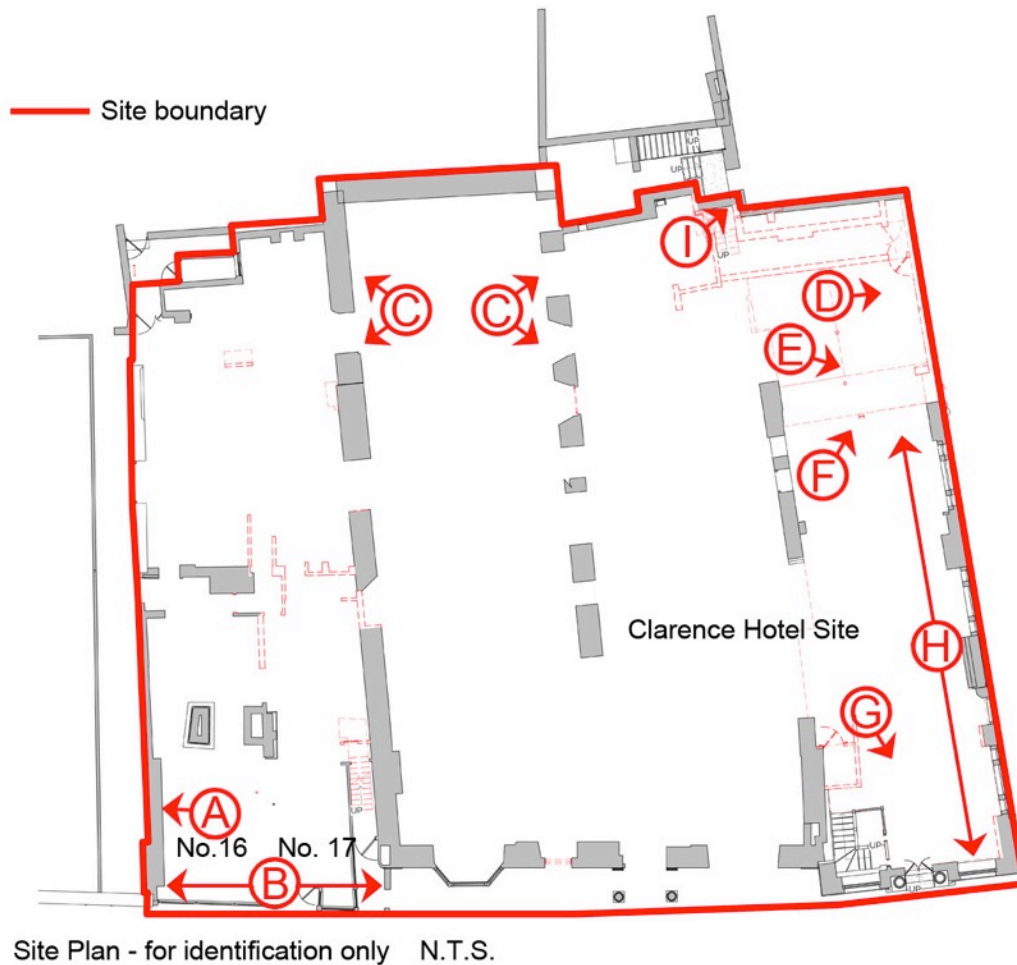
Figure 1. Identification Plan

5.1 The roof structures over both No.16 & No.17 have been largely replaced. The new construction seems to function satisfactorily and appears to be watertight, except at Location A – See 5.2.

5.2 Rainwater is penetrating the party wall between No.16 and the adjacent property to the west, resulting in an active fungal outbreak in timbers in the party wall and adjacent flooring below. This is presumably caused by a blockage and/or failure in the rainwater discharge from the new roof.
