**British Standard 5837:2012
Arboricultural Survey**

*Former Aldens Farm Land
Alphington
Exeter
Devon*

7th August 2017

Ref no: TH/X1626/0817

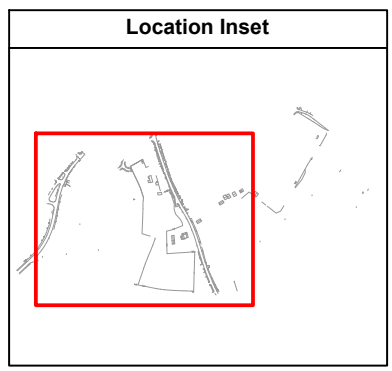
Drawing Title:
Tree Constraints Plan (West)

- Shading, dominance and nuisance are not considered to be an issue for the hedgerows as these have been flailed to a set height.
- It is noted that the tongue of land to the west of hedgerow H11 is outside of the ownership of the proposed development land and does feature some large Poplars (areas A5 and A6). Whilst none of these trees are individually or collectively outstanding, their removal cannot be assumed and their shade paths have been marked on the Tree Constraints Plan accordingly.

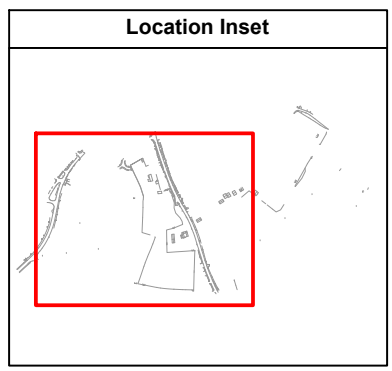
Drawing Title:
Potential Development Zones Plan (West)

3.12 Potential Development Zones – Gardens / Open Space	
<ul style="list-style-type: none"> • Areas recommended for gardens and open space are shown around the boundaries of the fields, and within the root protection areas of trees which are considered worthy of protection. • The areas shown for landscaping either already contain vegetation, including trees and hedgerows, or are recommended for the provision of new landscaping as part of the overall landscape scheme for the project. This is for the benefit of both existing neighbours, and for future residents. 	
3.13 Potential Development Zones – Summary	
• Occupied Structures	109,970m ²
• Infrastructure	13,735m ²
• Gardens / Open Space	18,170m ²

- Every effort has been made when drawing up the Potential Development Zones plan to recognise the need for pedestrian, cycle and vehicular links between the separate fields, and poorer quality areas of tree stock have been identified to enable this.
- It is noted that the vegetation between the existing public open space by Veitch Gardens and Royal Close, including the footpath link out to Shillingford Road, is relatively poor with the exception of hedgerow H13. It is recommended that any new development in this area takes the opportunity to improve and enhance hedgerows H18, H19 and group G5 so that it is in keeping with the needs and the character of the land on either side of this boundary.
