Tree Constraints - above ground

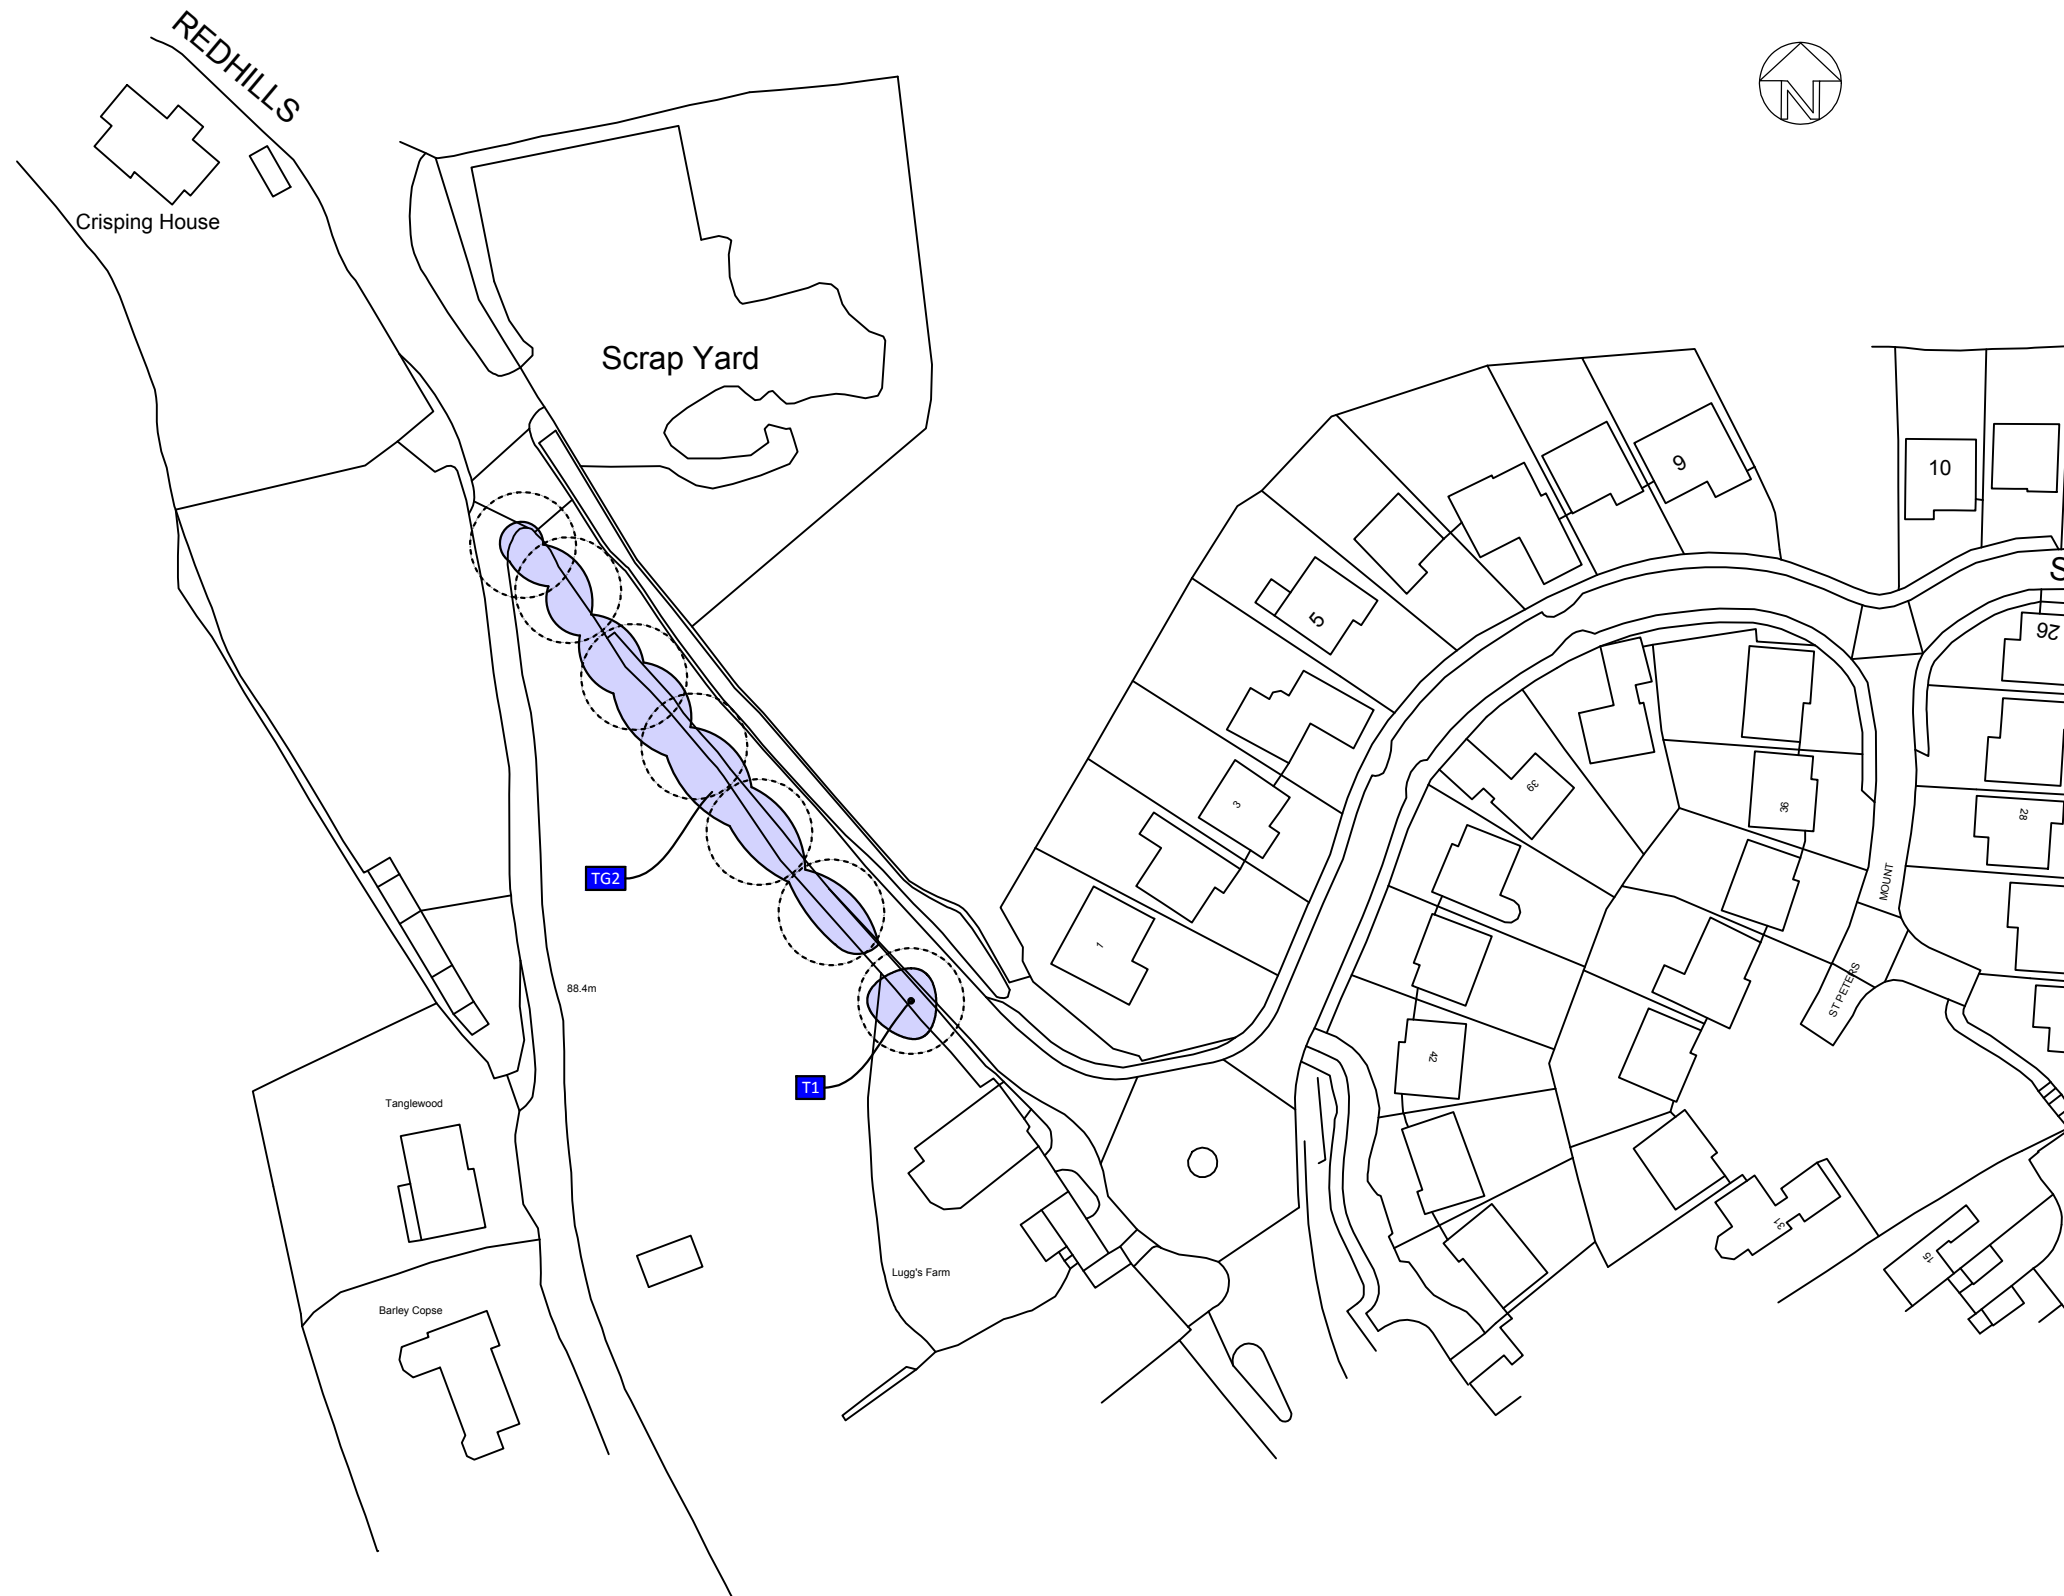
Tree survey ref & BS5837 category		Root Protection Area	
	T01 'A' cat T02 'B' cat T03 'C' cat T04 'U' cat

Default RPA BS5837:2012 Tx Individual Tree TGx Tree Group Hx Hedgerow Wx Woodland

Tree Survey Data						
Ref	Species	Hgt (m)	Stem (mm)	Crown Hgt (m)	Age	BS cat
T1	Oak <i>Quercus robur</i>	14	600	5	EM	B1
T1 is located in the highway verge in an elevated position.						
TG2	Ash (95%) <i>Fraxinus excelsior</i> Sycamore <i>A. pseudoplatanus</i> Oak <i>Quercus robur</i>	15-17	200-300	5	SM EM M	B2
TG2 is a linear tree group of multi stemmed coppiced trees, which have grown out of the original hedgerow along the top of the highway verge banking. The hedge has suffered from a lack of management and is now dominated by Ash and Sycamore, with the understorey now largely defunct. These trees will require re-coppicing in the foreseeable future.
